Presentation for Pawtuxet River Stabilization Project

Rebuilding After the Flood: A Holistic
Approach to Preserving History while
Enhancing Flood Resiliency

Sean D. Arruda, P.E., CFM, Fuss & O'Neill, Inc., Providence, RI

October 25, 2017

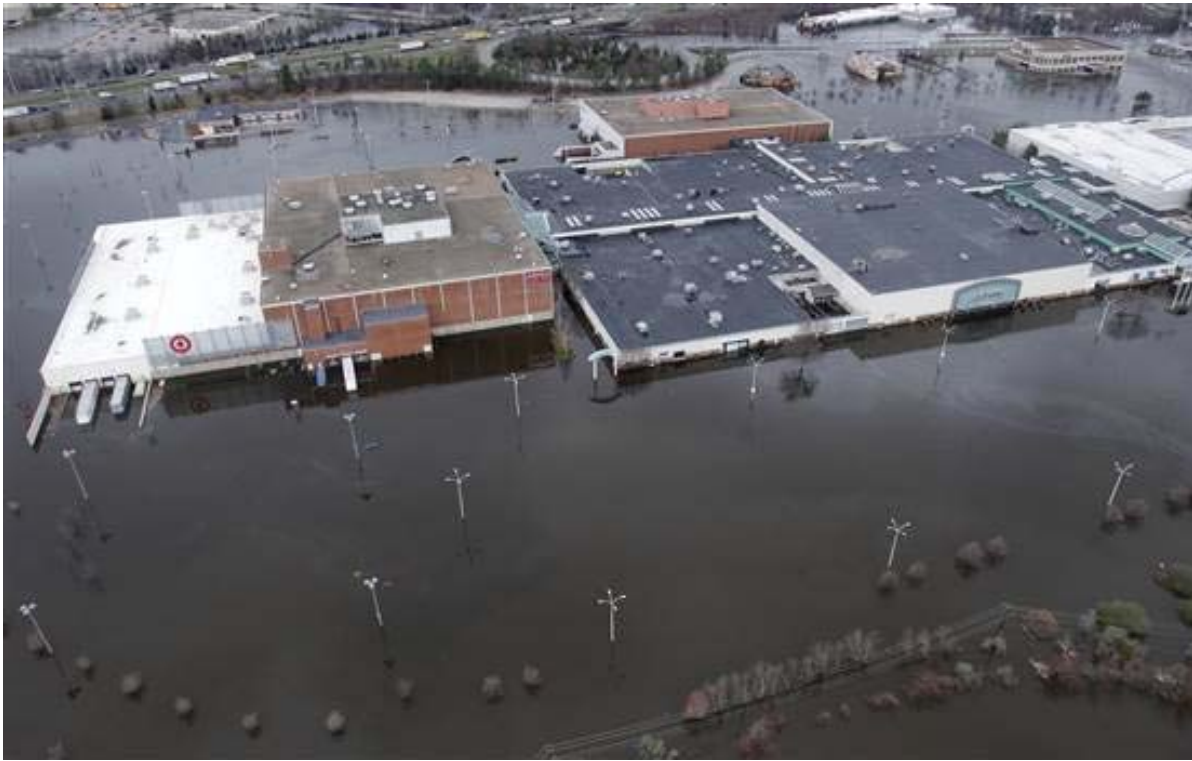
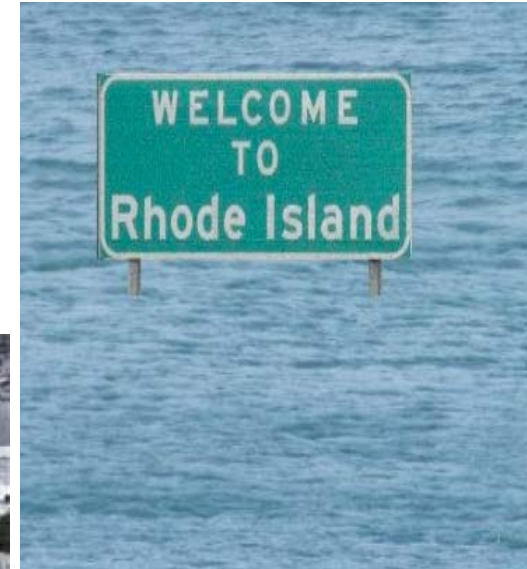
- Between March 29 and April 1, 2010, 8.8 inches of rain fell on the Pawtuxet River watershed in Rhode Island.
- 11.3 inches of rain fell over the previous 35 days (Category III Antecedent Moisture Conditions).
- Coupled with the level of development/impervious area in the Watershed, this resulted in a flooding event with a 0.2% annual exceedance probability or greater.
- On the Pawtuxet River, this flooding exceeded the previous flood stage record by about 6.3 feet.

1. 20.77 ft.	CURRENT
2. 14.98 ft.	3/15/2010
3. 14.50 ft.	6/07/1982
4. 13.68 ft.	10/15/2005
5. 13.26 ft.	1/26/1979

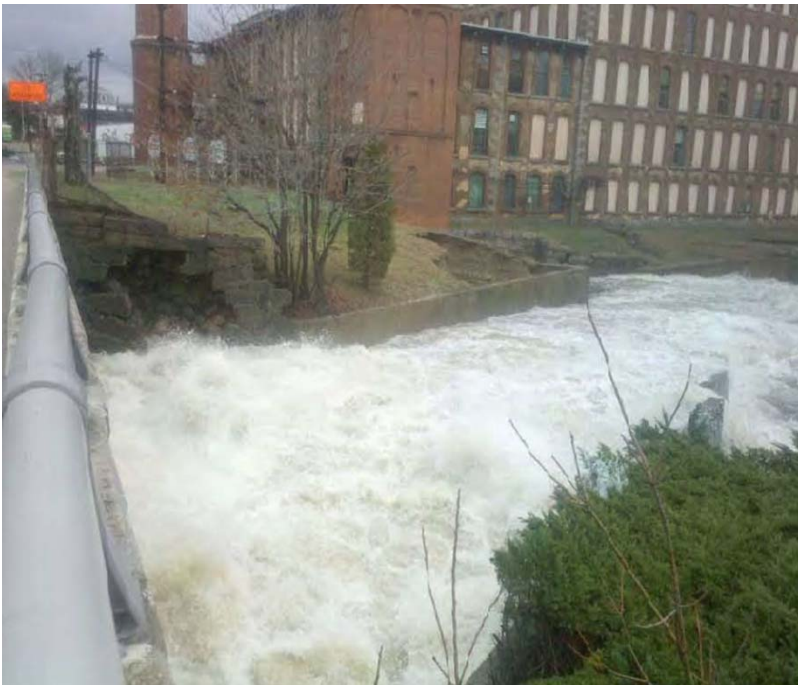
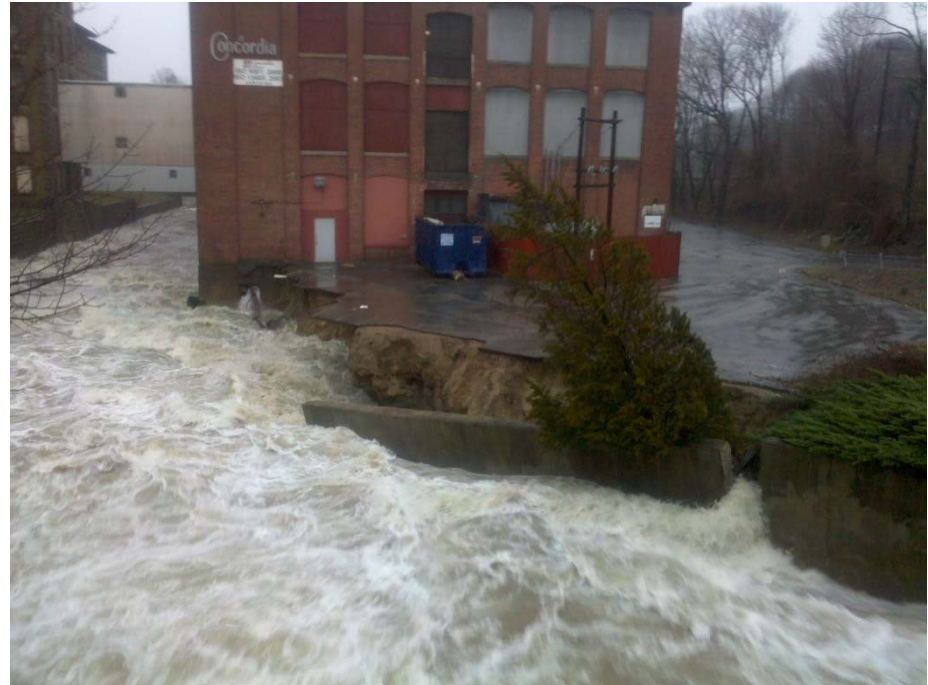
- High flow and flow velocities resulted in substantial scour along the river channel bottom and banks.
- This led to the failure of the river channel bottom, river walls, and adjacent up-gradient river bank areas.

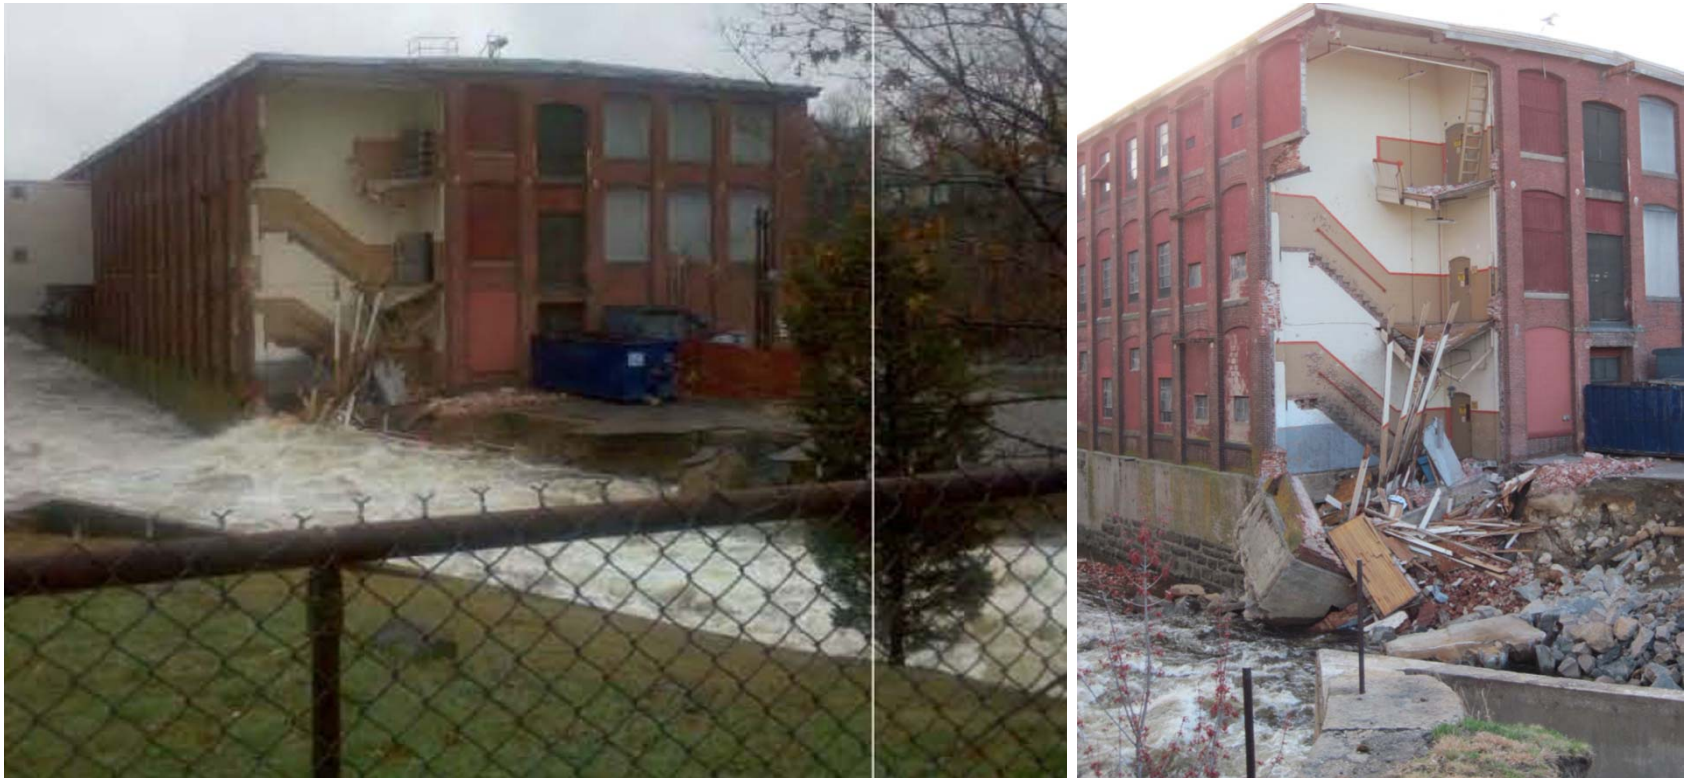
- This ultimately resulted in the collapse of the corner of the Concordia structure and the undermining of Anthony Mill's historic six-story stair tower.

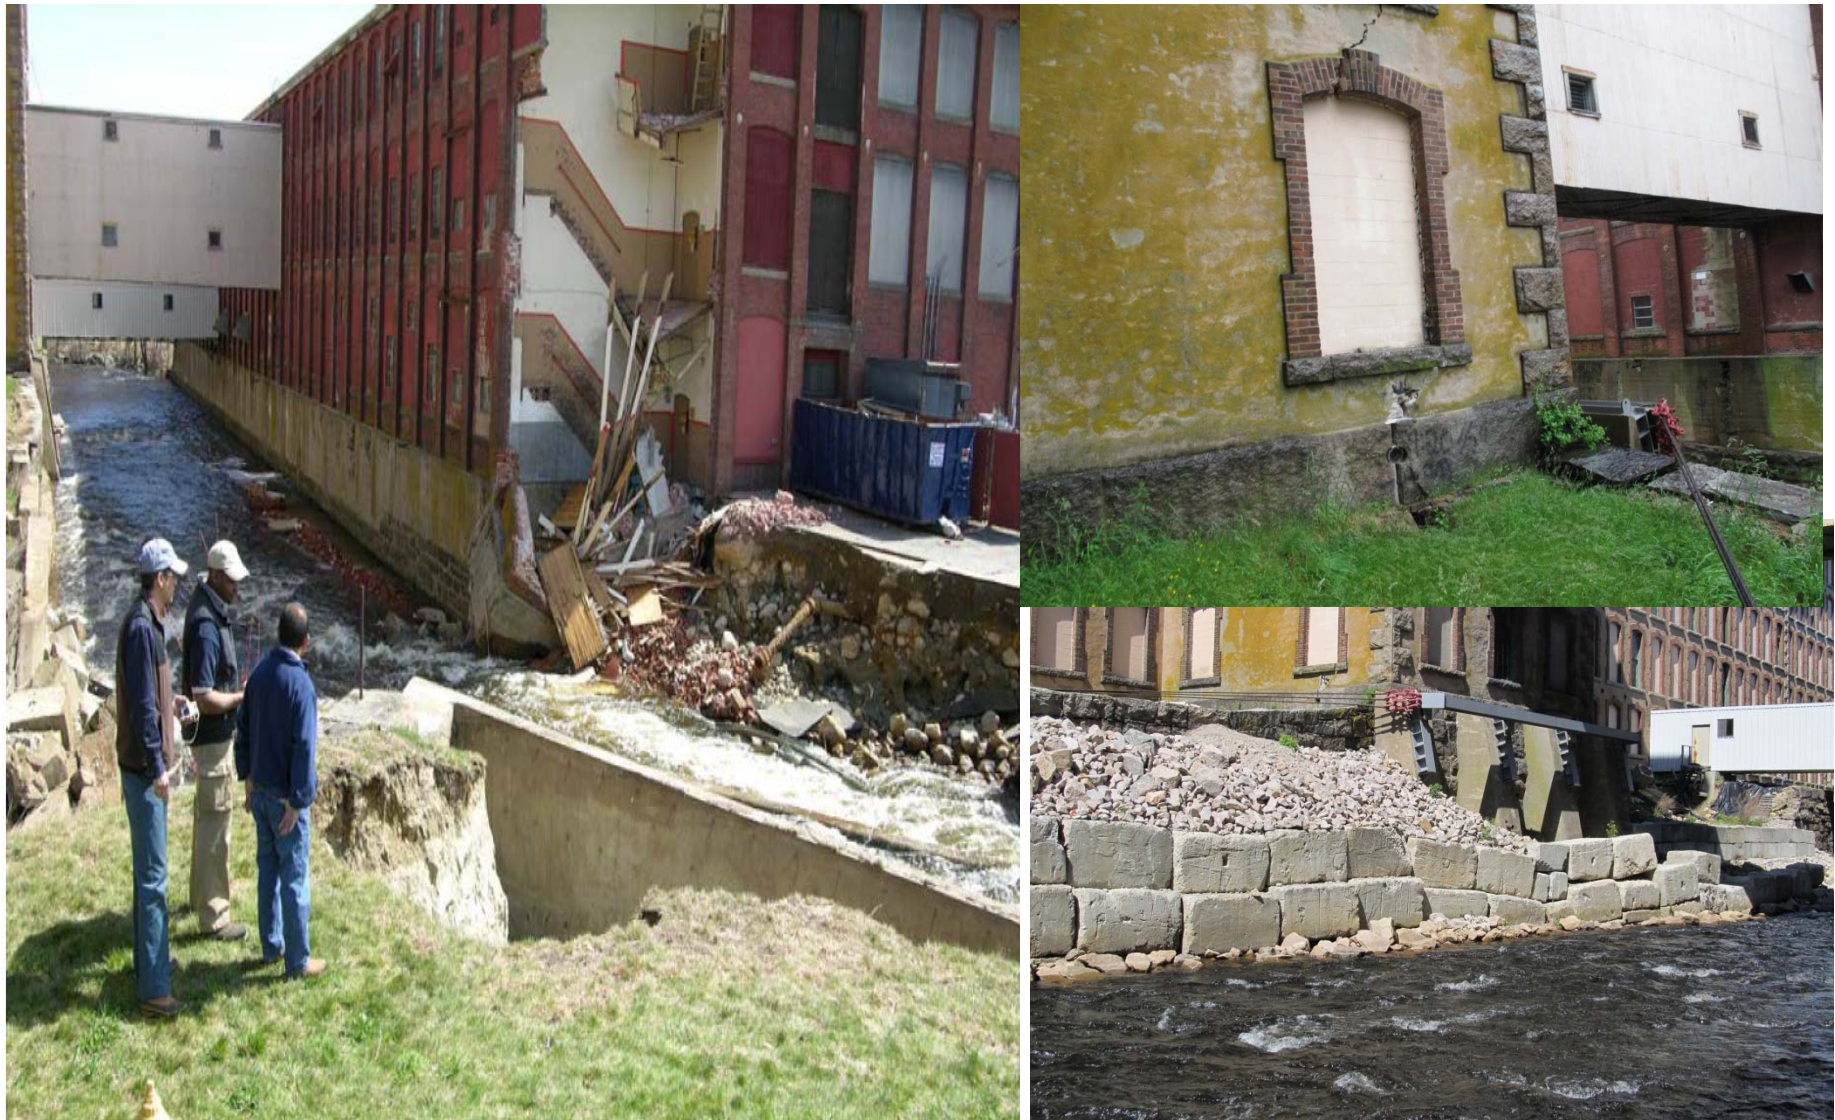
Post-Flood March 2010 Impacts at Project Site:

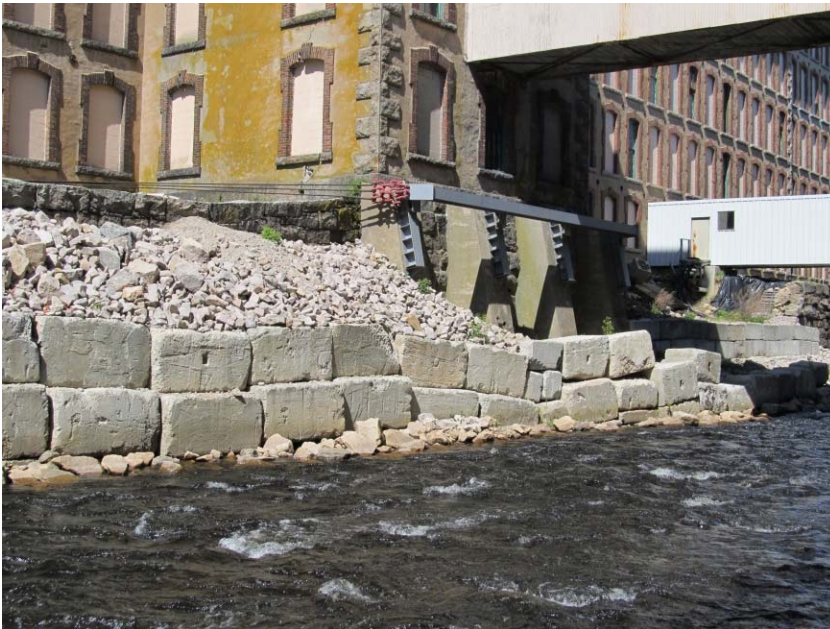
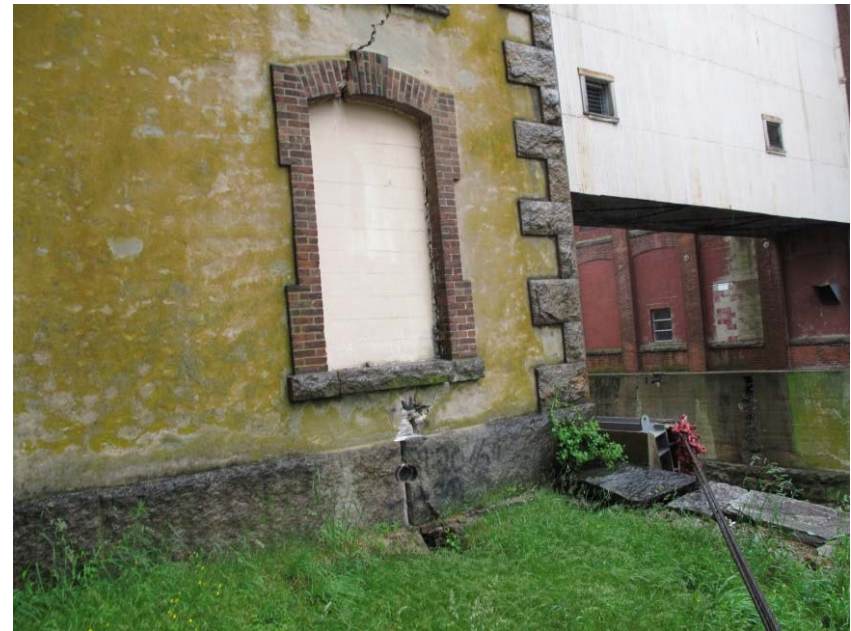
Stair Tower Structural Impacts

- Undermining and voids beneath structure
- Horizontal movement of Structure (separation from main building)

- Selected Alternative needed to:
 - Stabilize existing foundation in place; while
 - minimizing excavation, undermining and risk of damage
- As a result, the following structural measures were implemented
 - Micro-piles
 - Tie-backs
 - Concrete collar to encompass stone masonry foundation

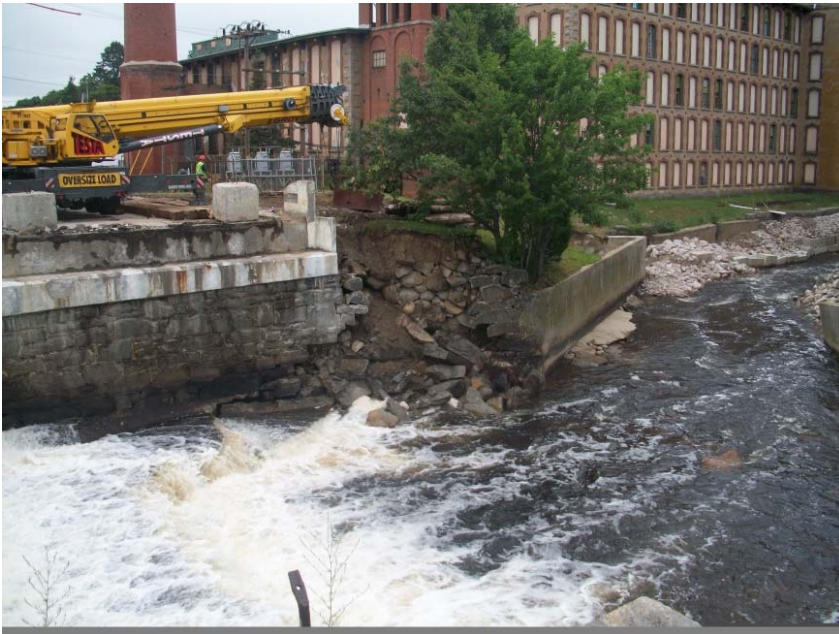
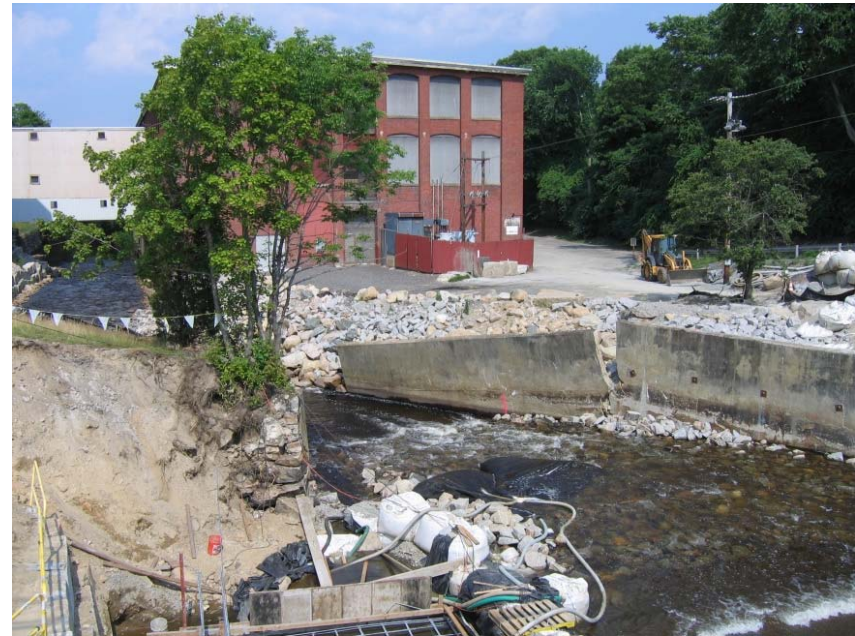
Retaining Walls

- Severe undermining
- Loss of backfill
- Failure/collapse in several locations

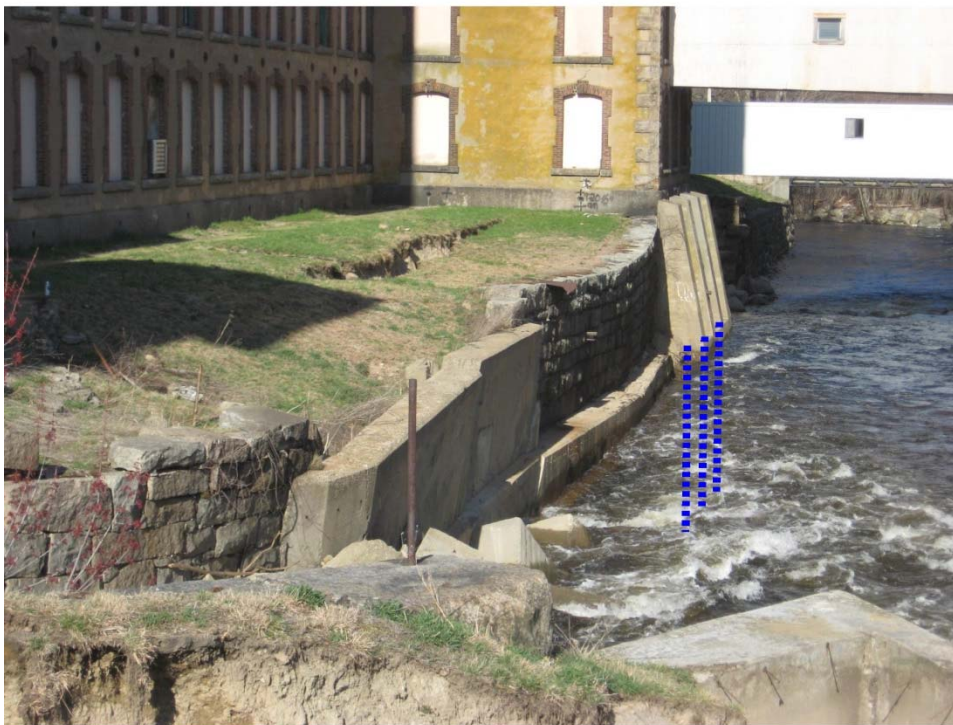
1. Micropile Installation to stabilize buttress foundation

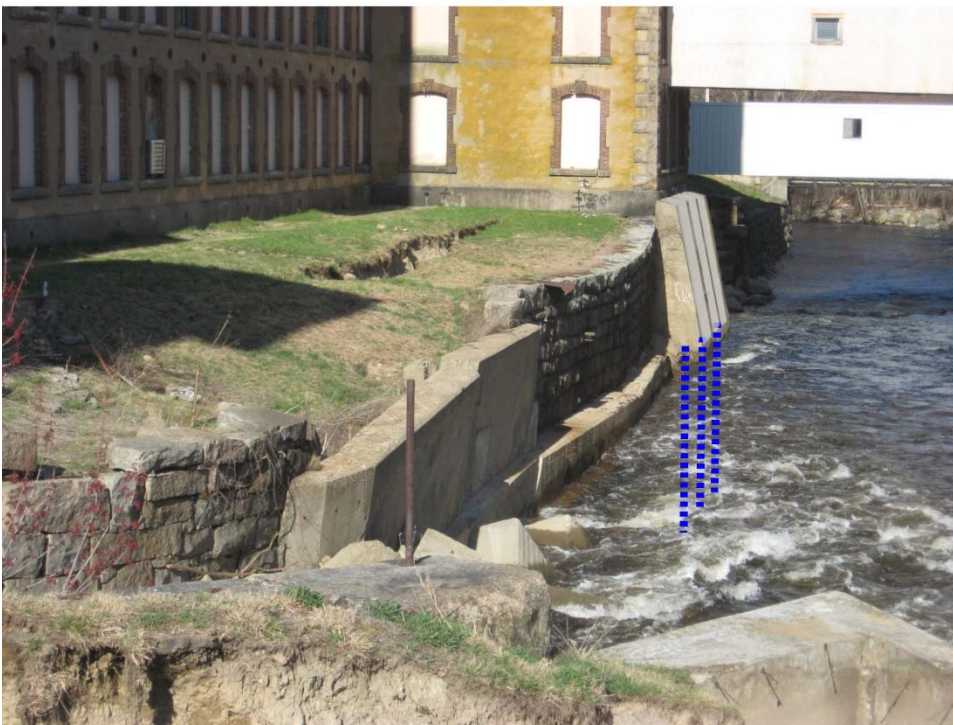
2. Buttress Further Reinforced

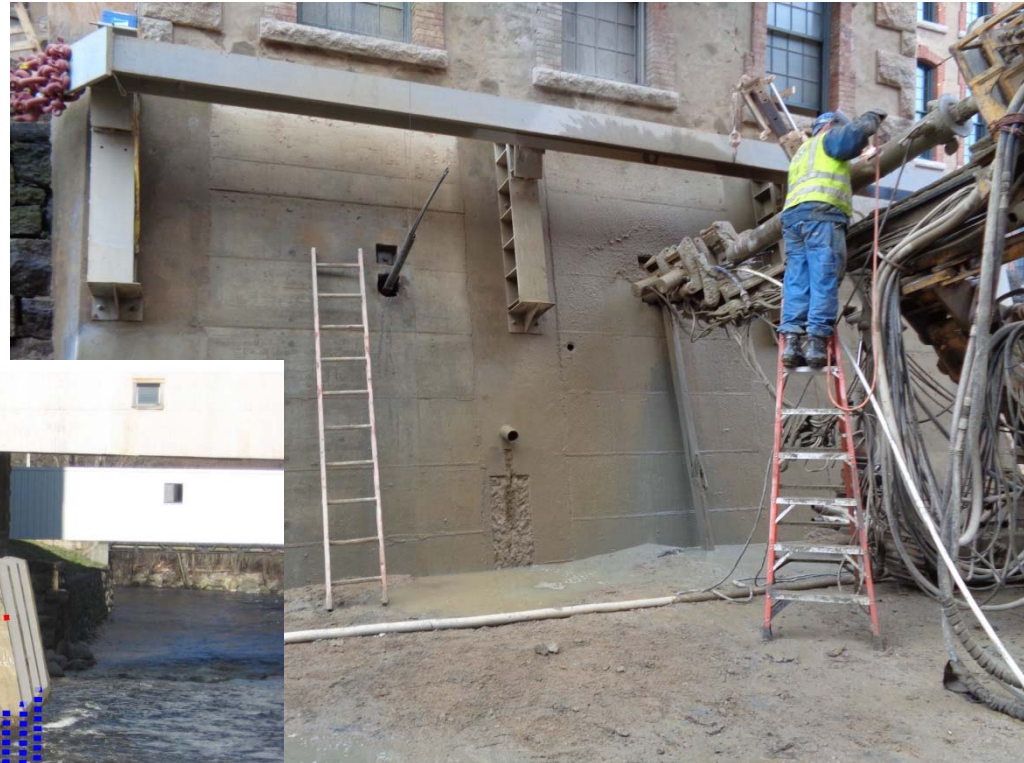
3. Tie-Back Installation

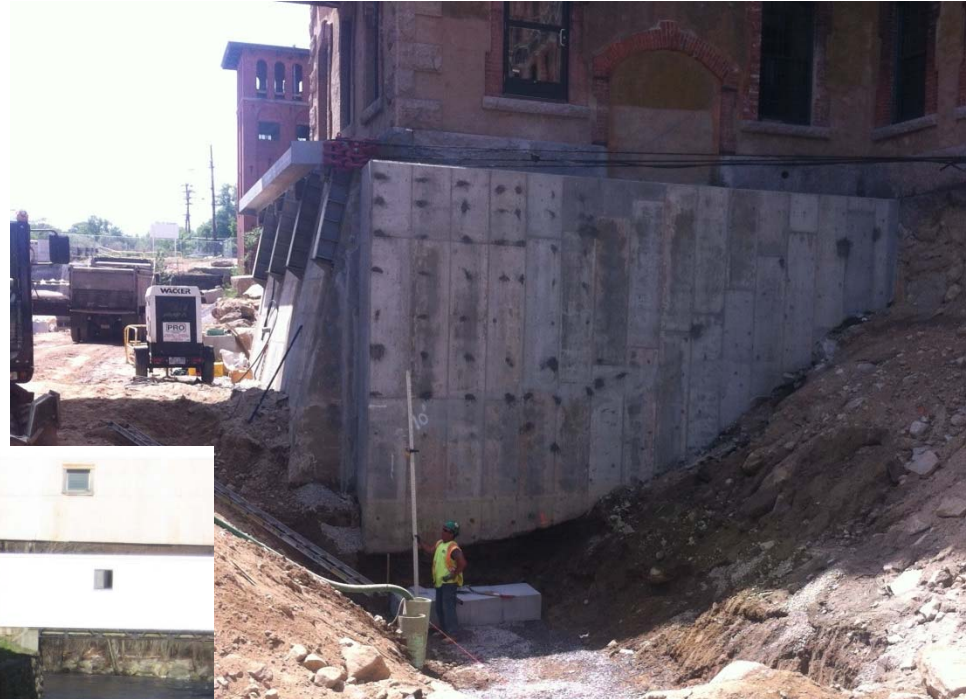
4. Reinforced Concrete Collar Walls Constructed Around Existing Masonry Foundation

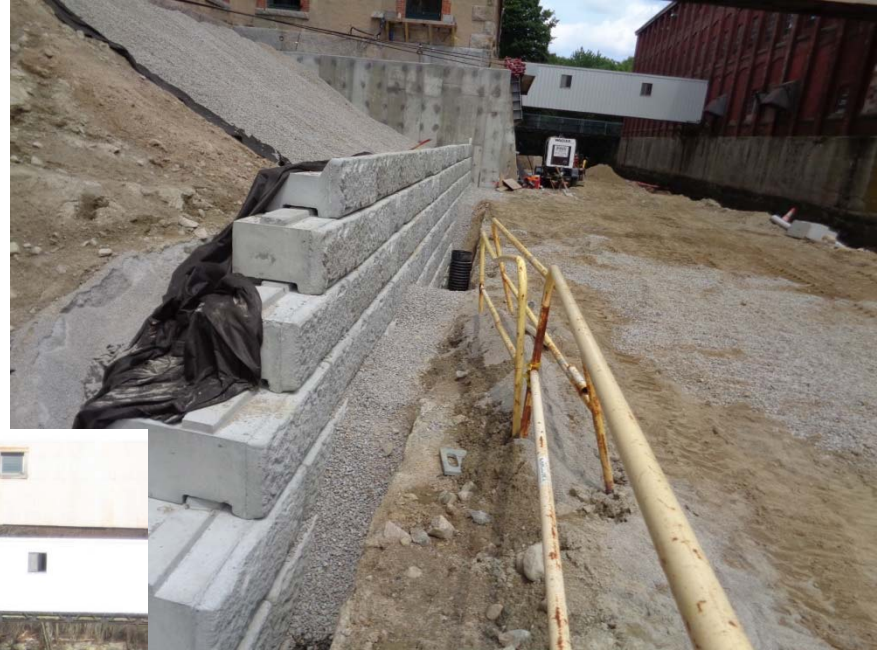
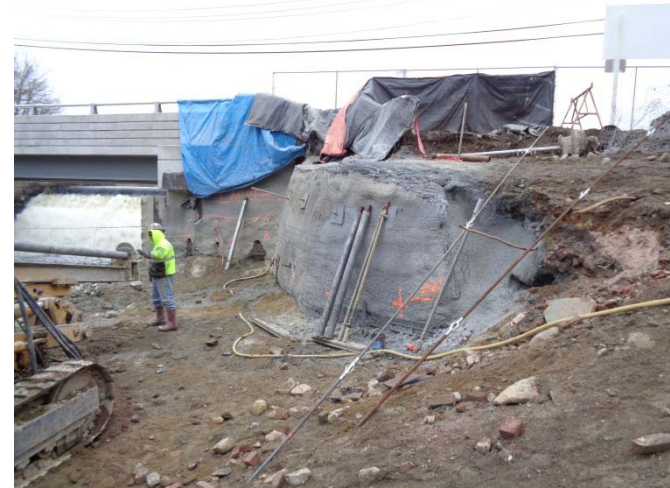
5. Modular Block Retaining Walls Were Constructed Along Riverbanks

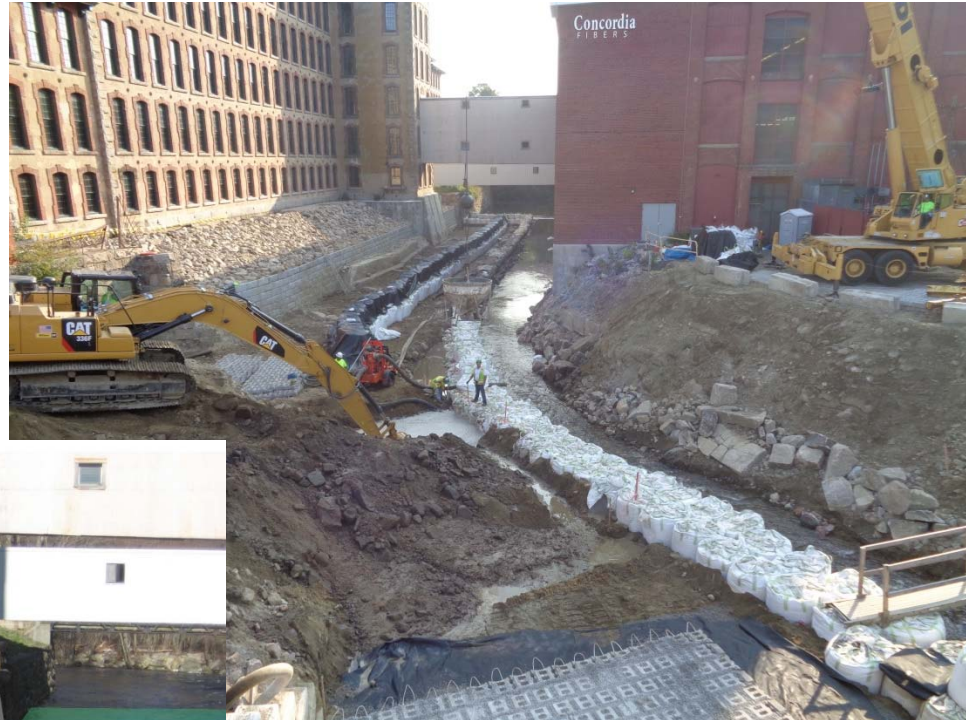
6. Upper Banks of River Stabilized with Stone Slope Protection

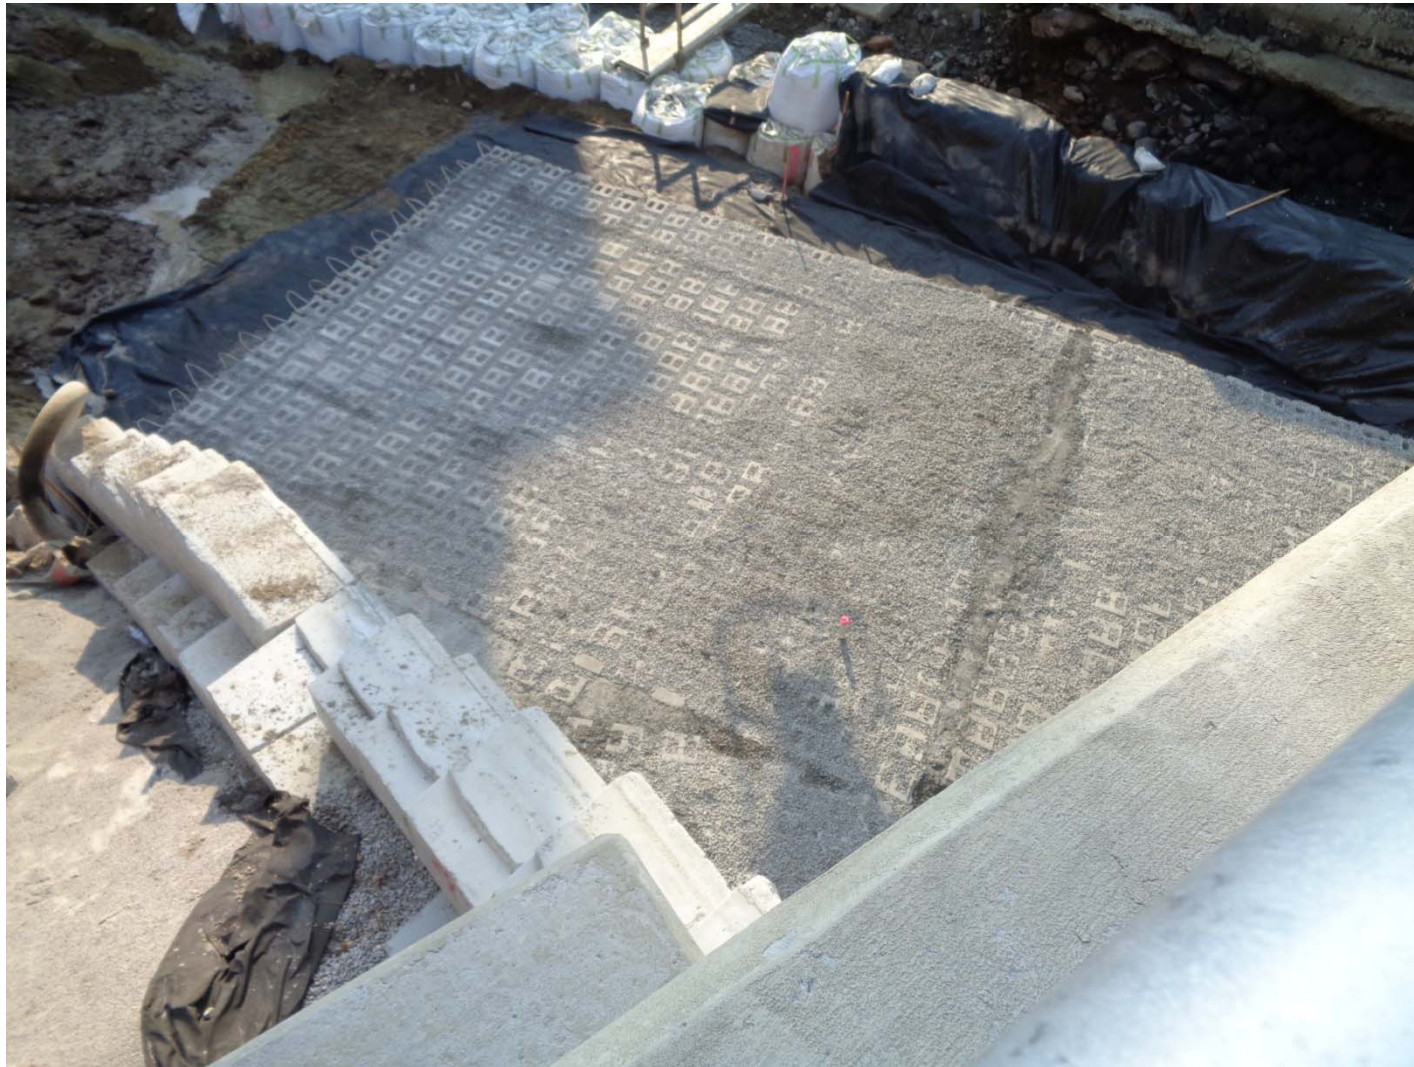
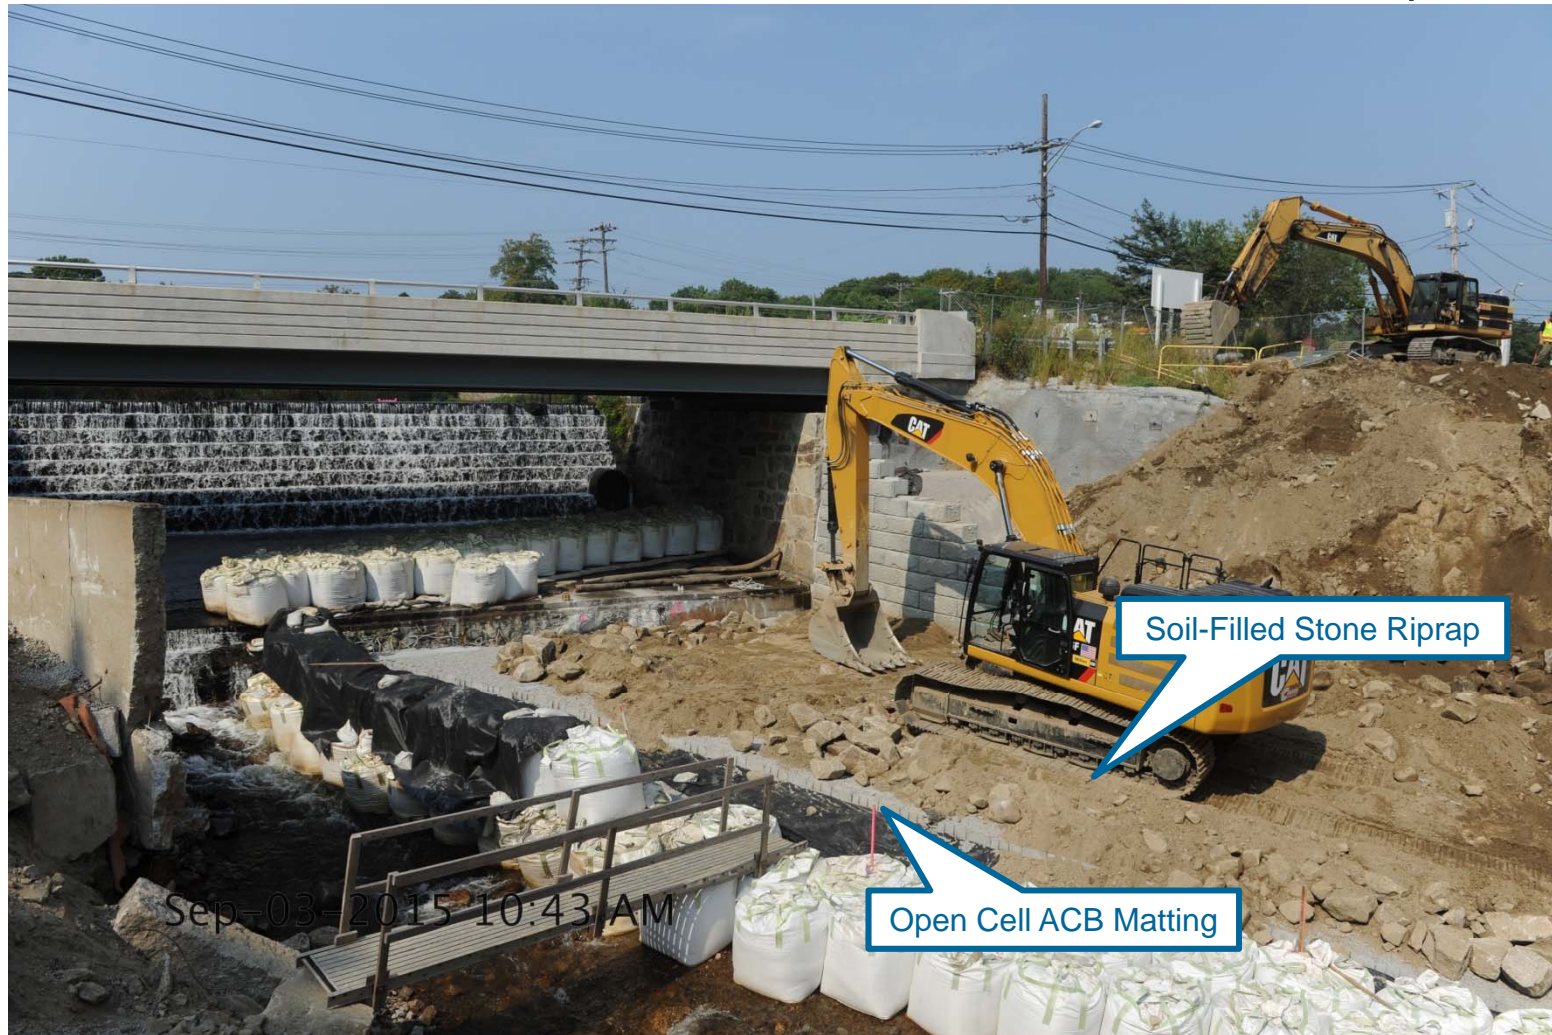
- Two-Tiered Channel Bottom Scour Control System in locations where scour anticipated to be the greatest

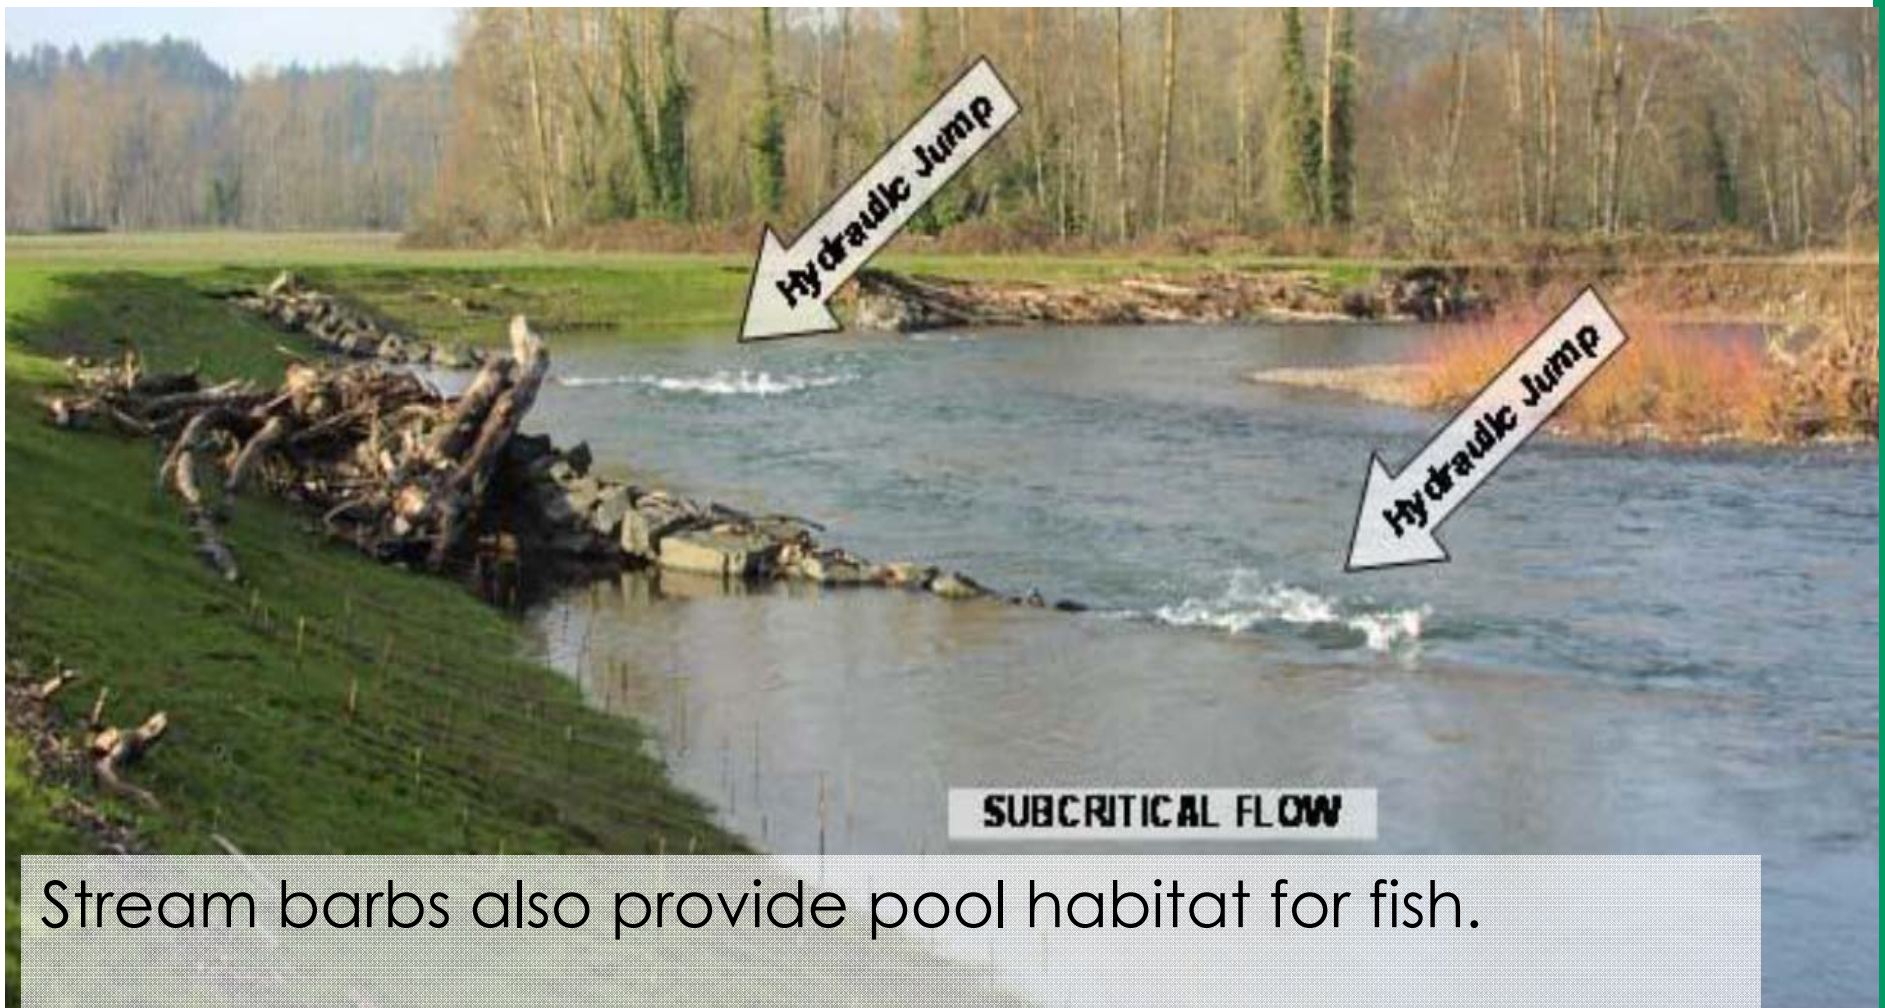
- Stream Barbs and Stone Arch Weirs proposed for energy dissipation and to divert energy/flow away from river walls

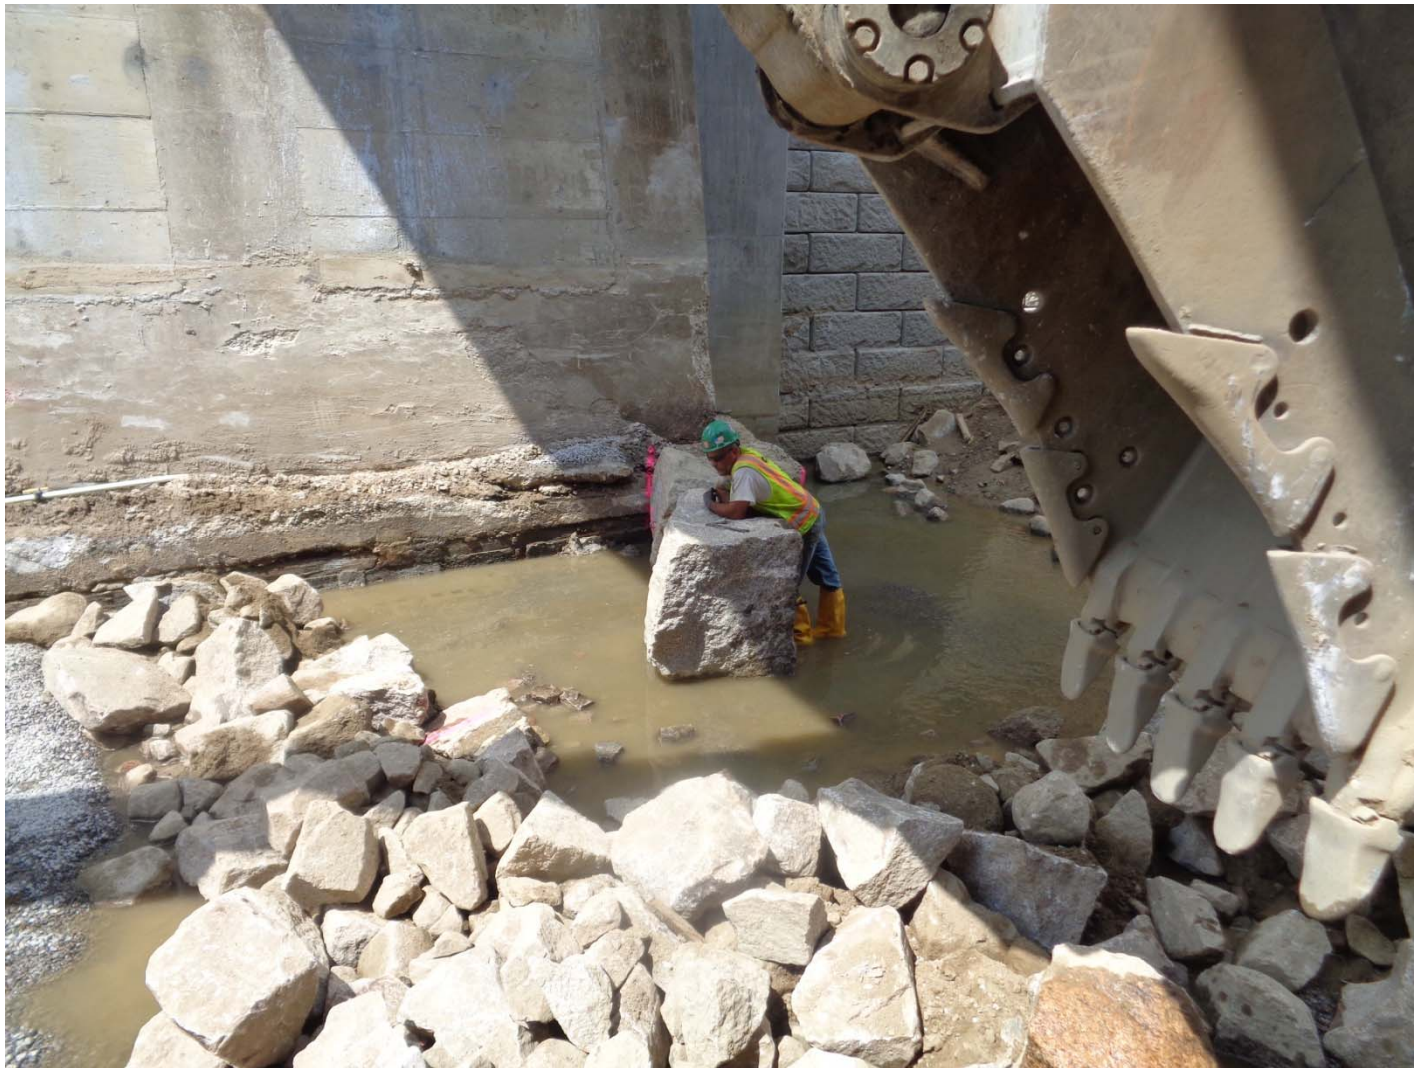
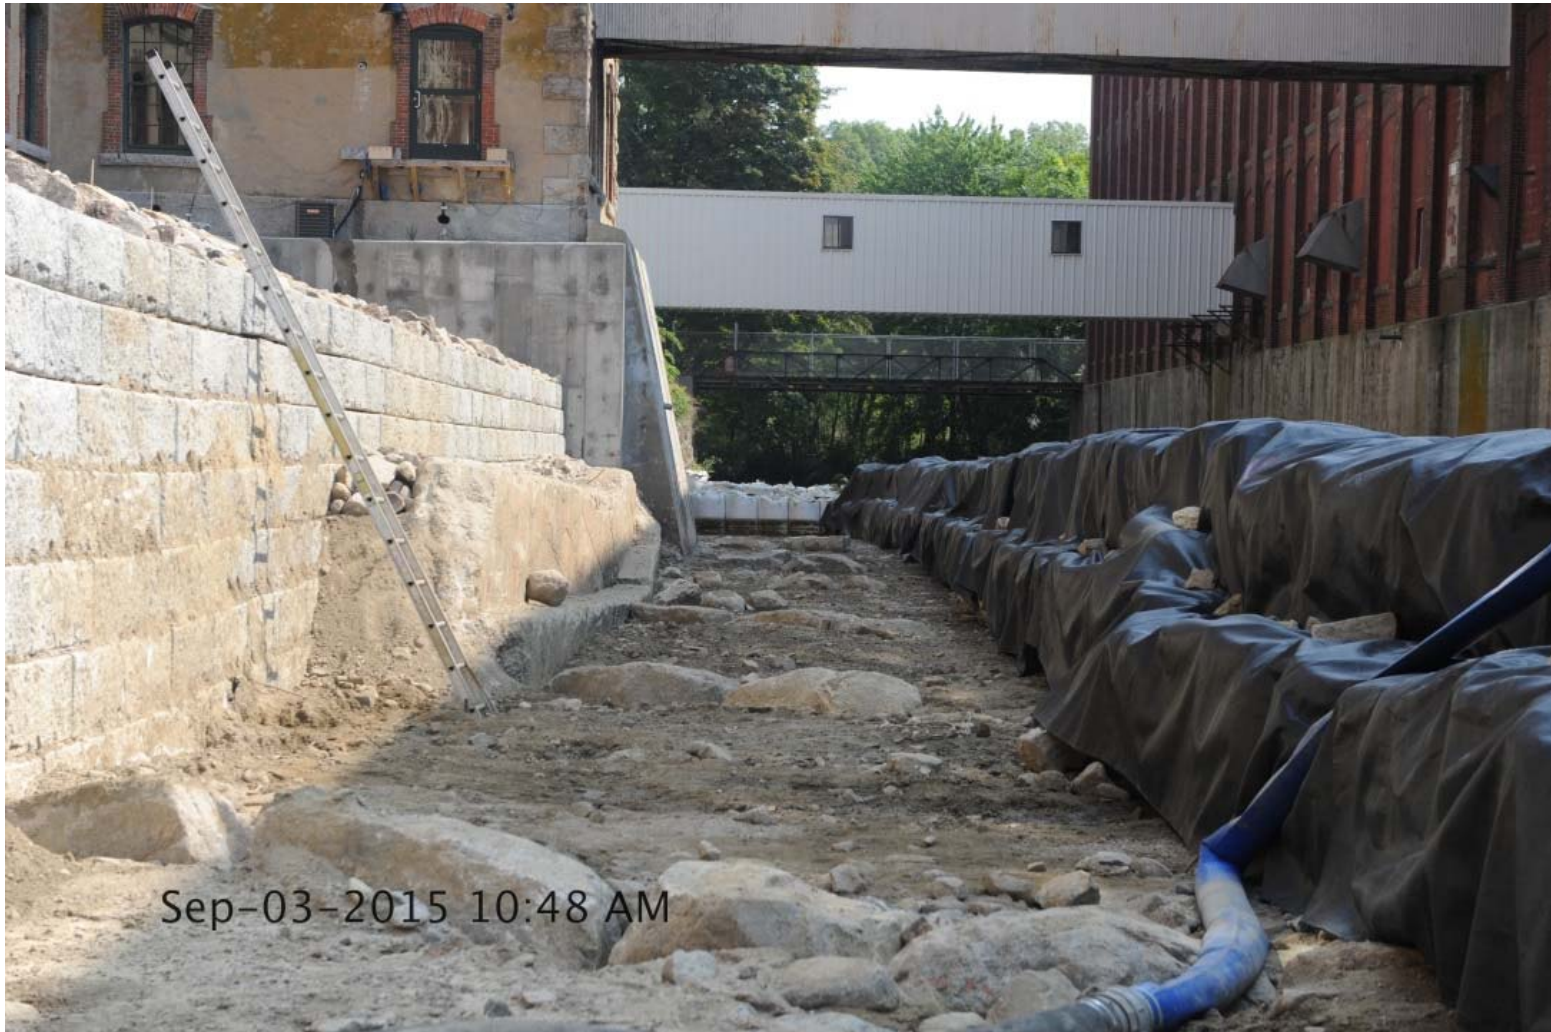
- Stream Barb Construction
