Presentation for Pawtuxet River Stabilization Project

Rebuilding After the Flood: A Holistic
Approach to Preserving History while
Enhancing Flood Resiliency

Sean D. Arruda, P.E., CFM, Fuss & O'Neill, Inc., Providence, RI

October 25, 2017

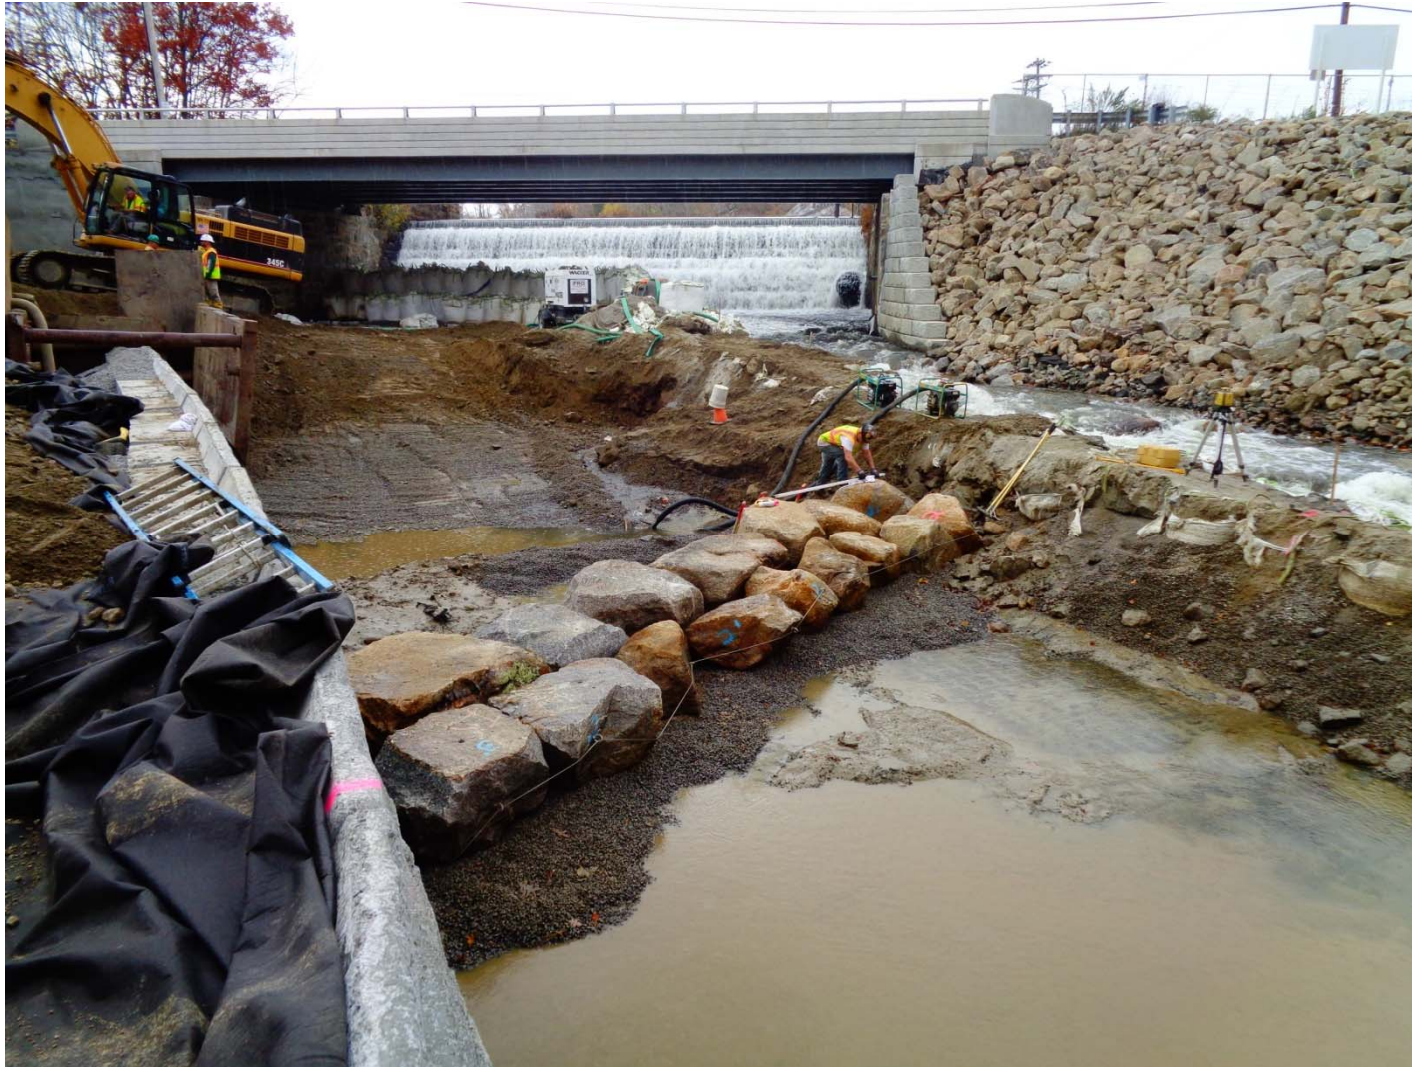
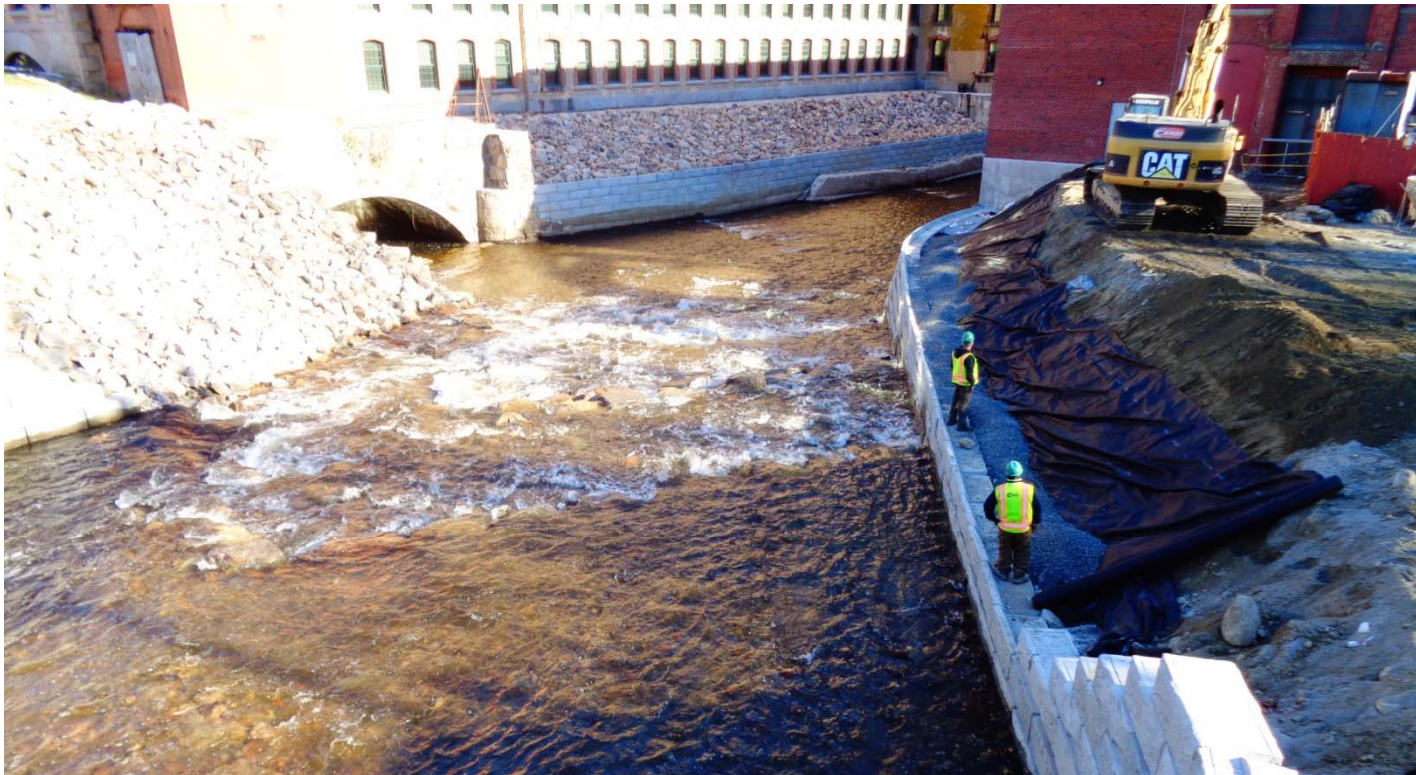
- Stone Arch Weirs

- Hydraulic modeling confirmed that the arched weirs reduced the energy grade line in steep section of reach from 7.6% to 1.6%.

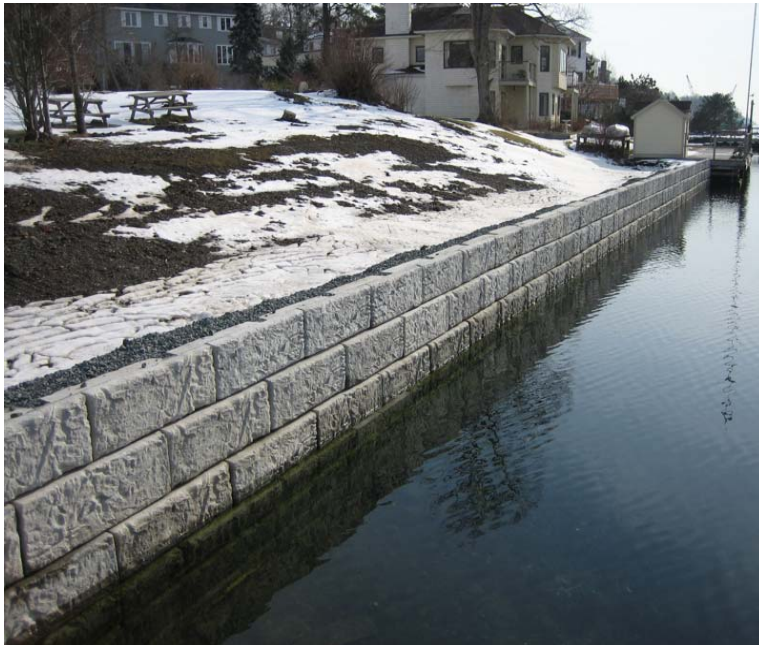
- Pre-Fabricated River Walls and Stone Slope Protection
 - Pre-Fabricated River Walls were proposed to save project costs and stay within allotted funding
 - Finish of walls were consistent with granite appearance

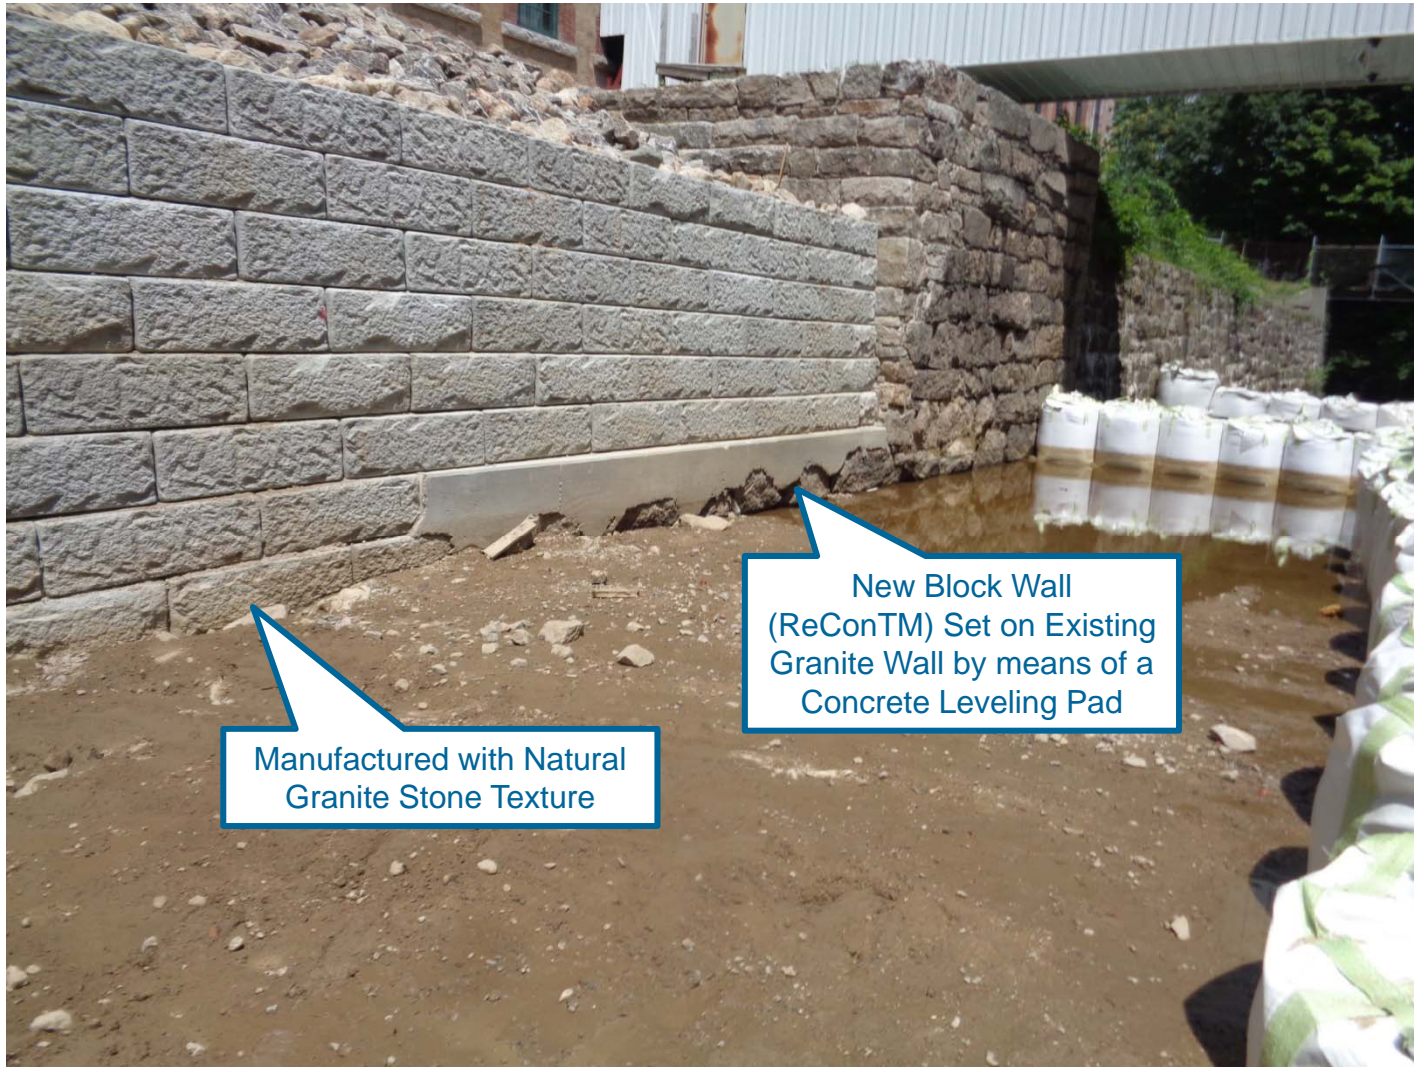
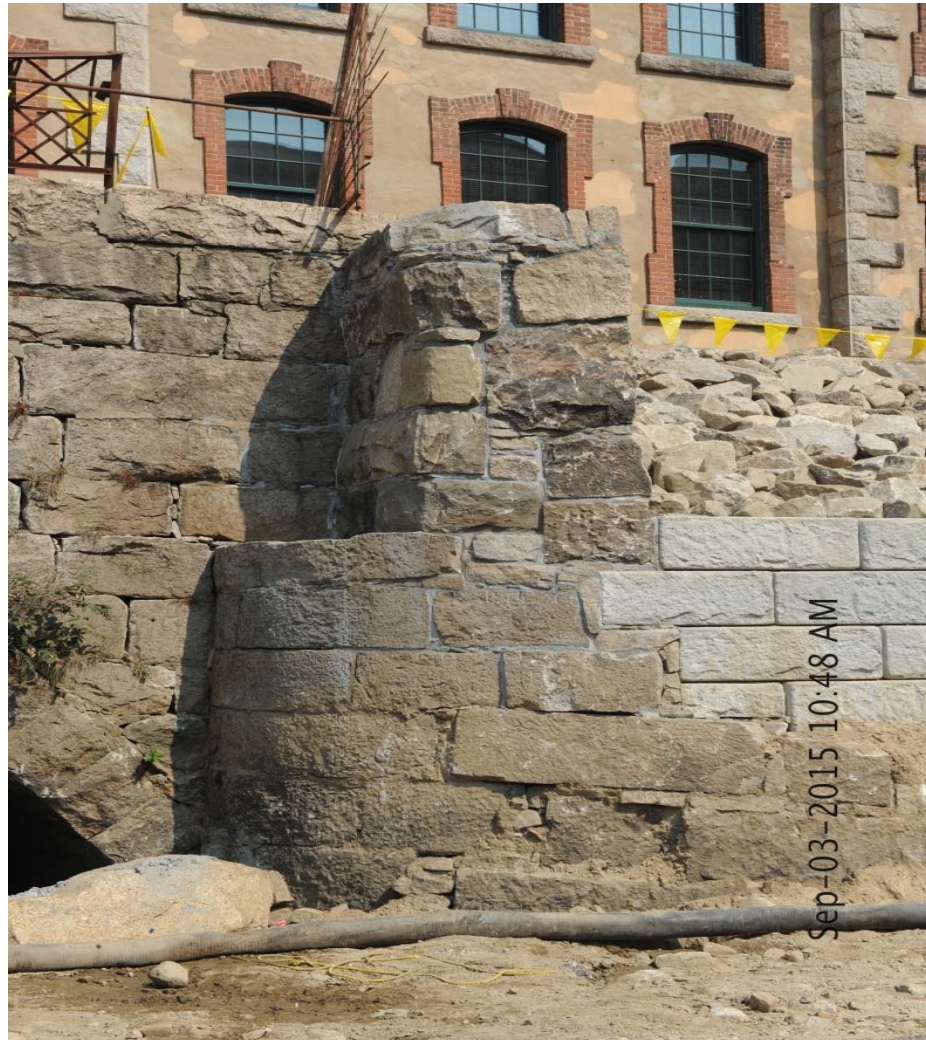
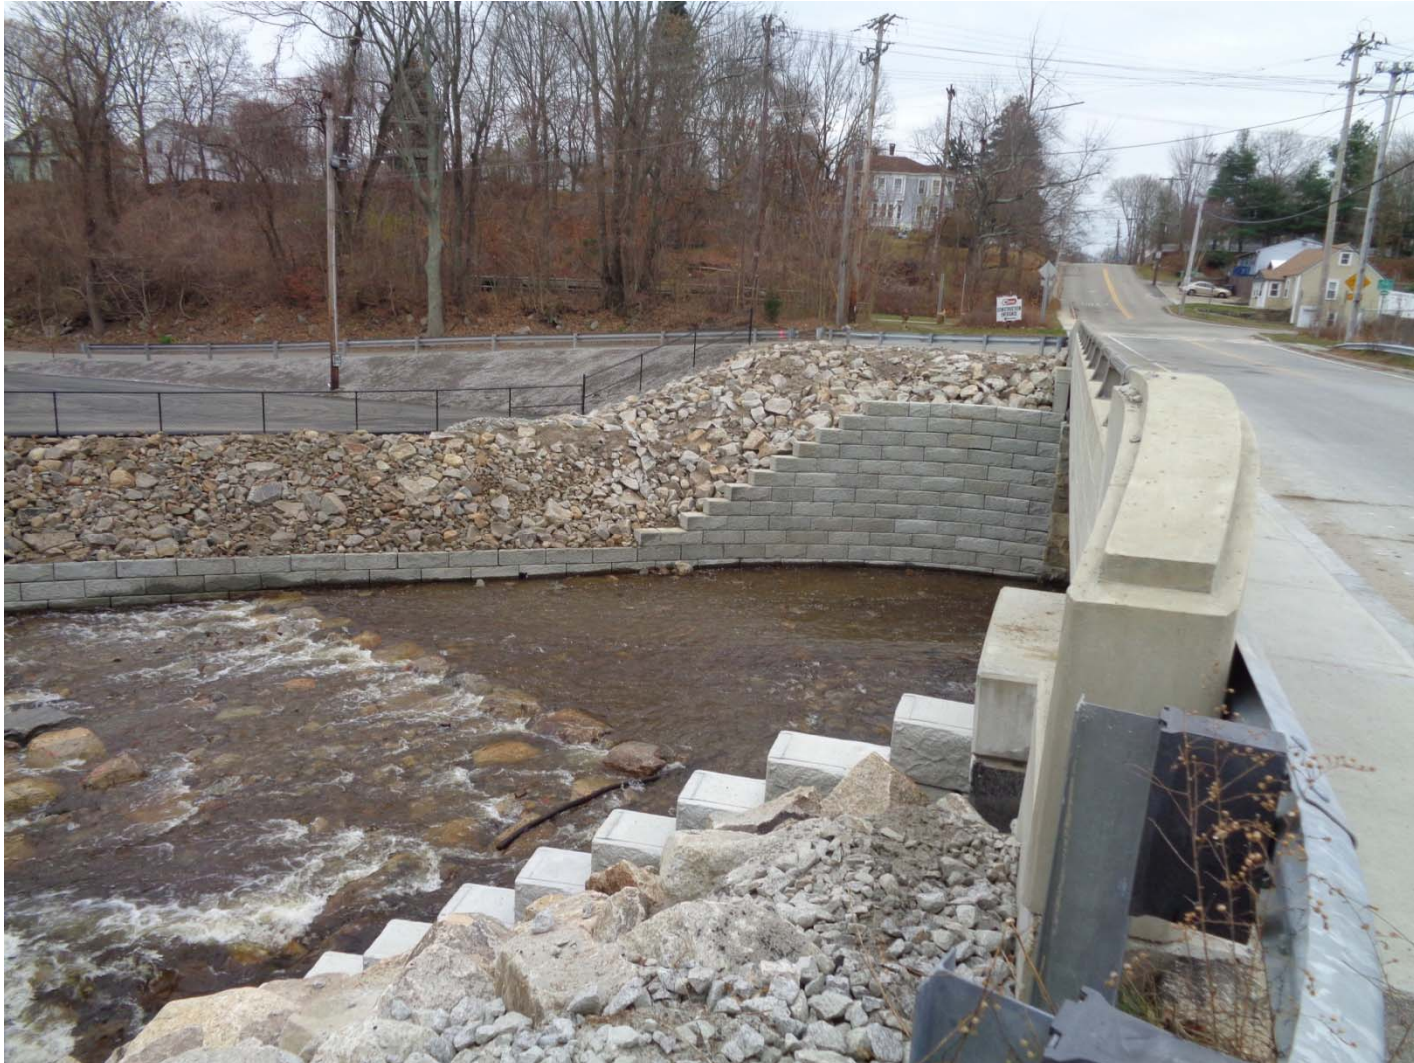
- Pre-Fabricated River Wall System

- Pre-Fabricate River Wall System Connect to Exist. Granite Walls

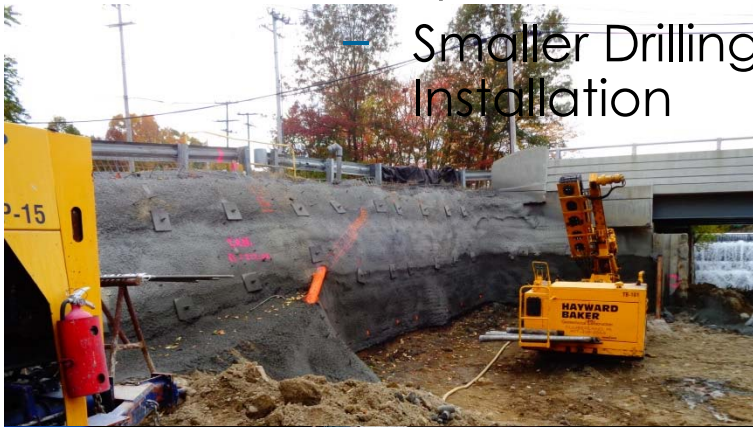
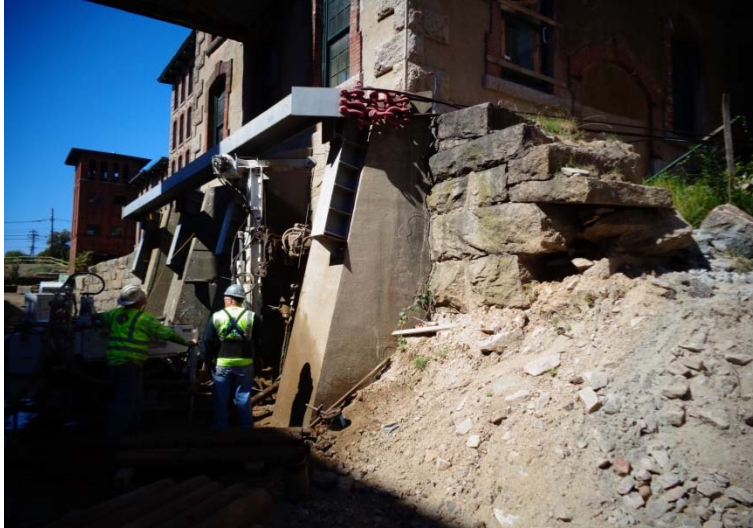
- Poor construction access and limited work space.
 - Temporary Soil Nail Walls required to construct river wall system near bridge
 - Smaller Drilling Equipment required for Micropile Installation

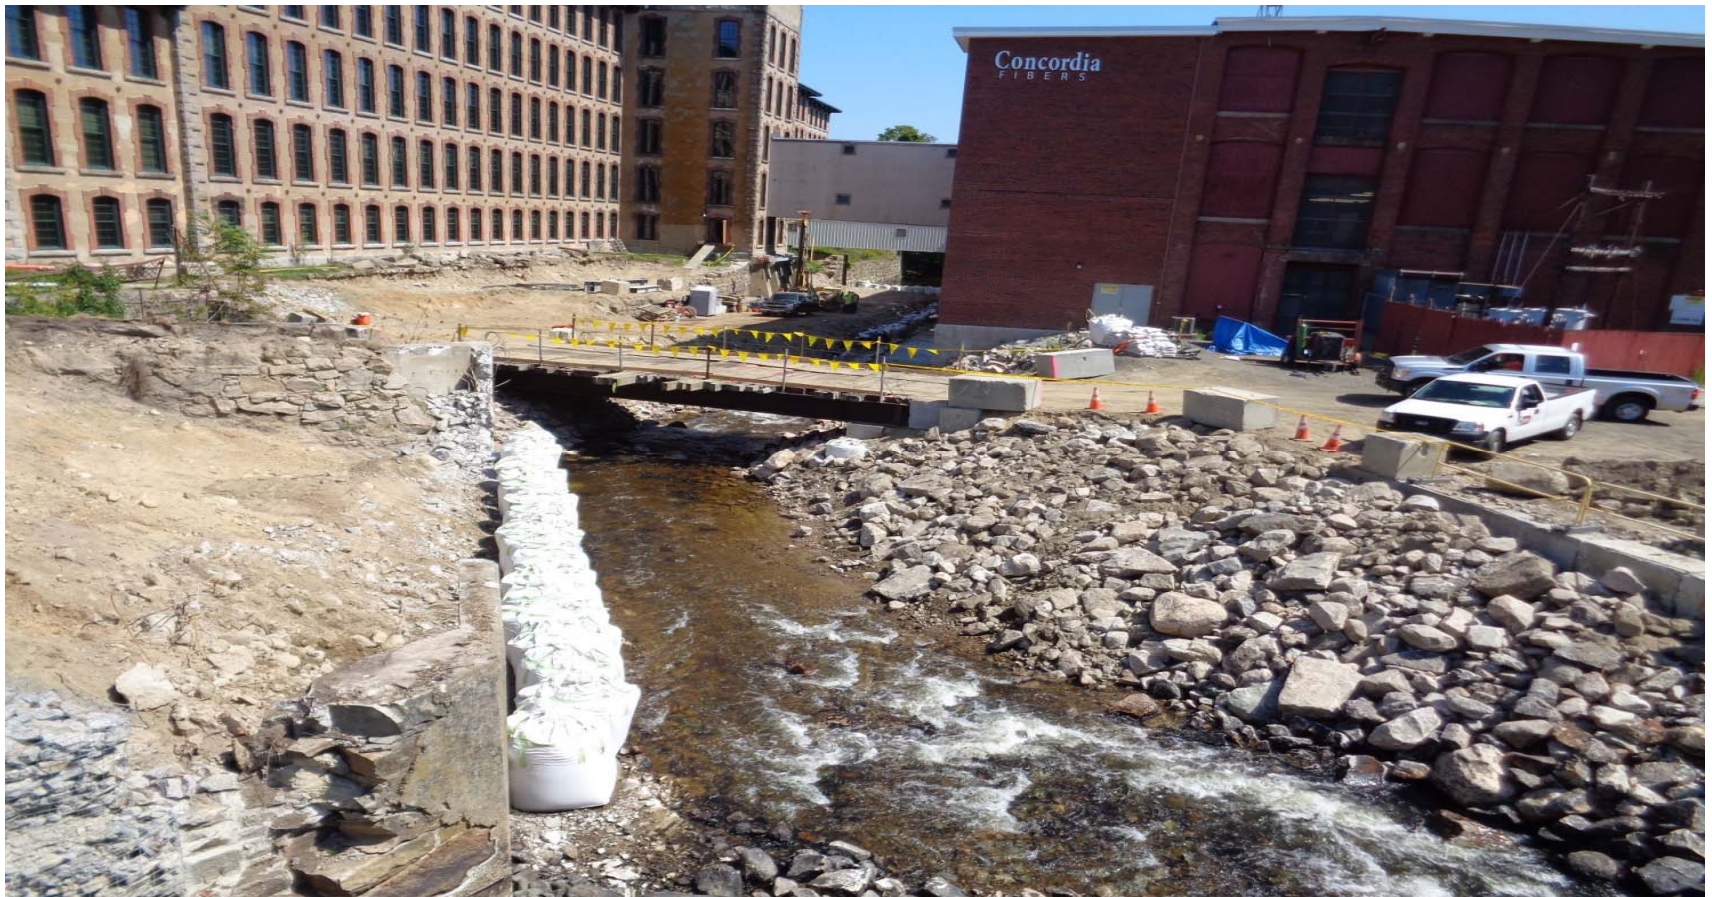
- Temporary Bridge necessary to gain access to north side of river due to limited construction access

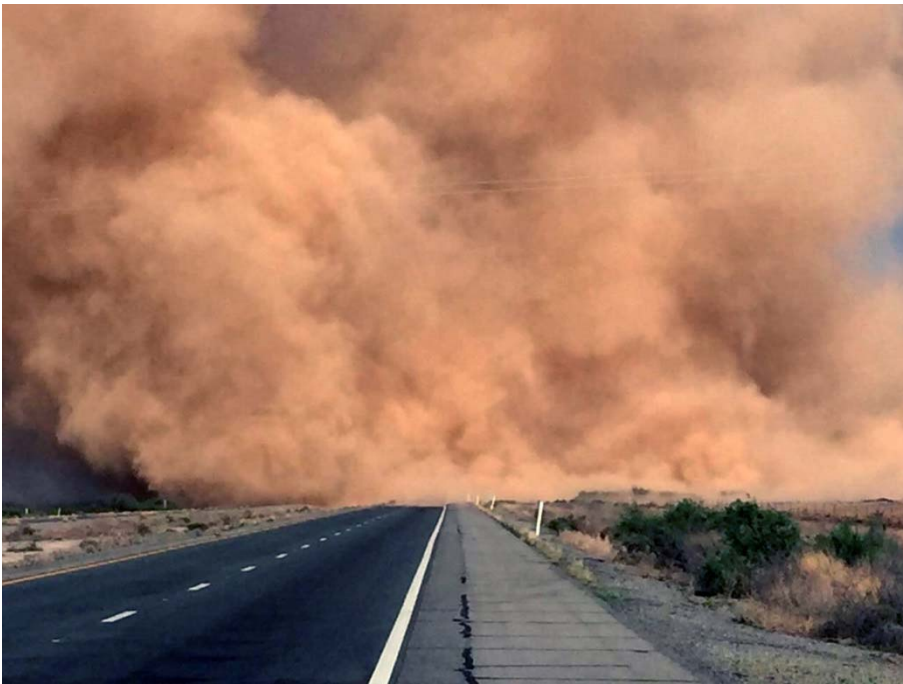
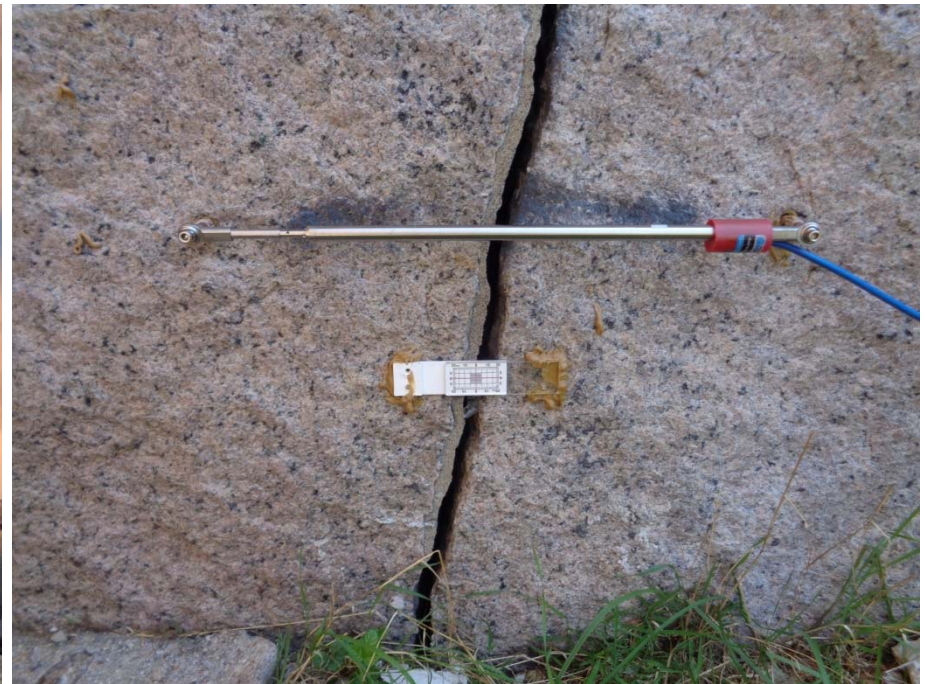
- Work within an active business zone and residential complex.
 - Dust Control (especially during summer months)
 - Vibration and Crack Monitoring

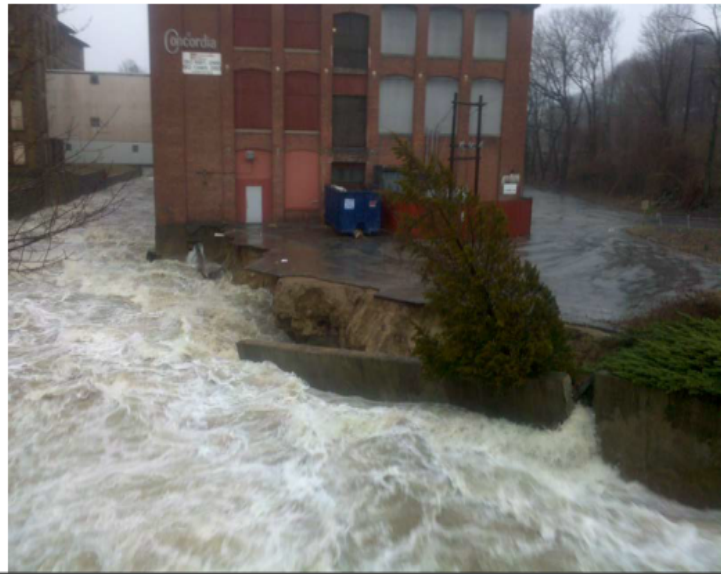
March 2010: Peak flood flows in the Pawtuxet River during the historic storm event. The riverbank is eroded but the building at Concordia Manufacturing is still intact.

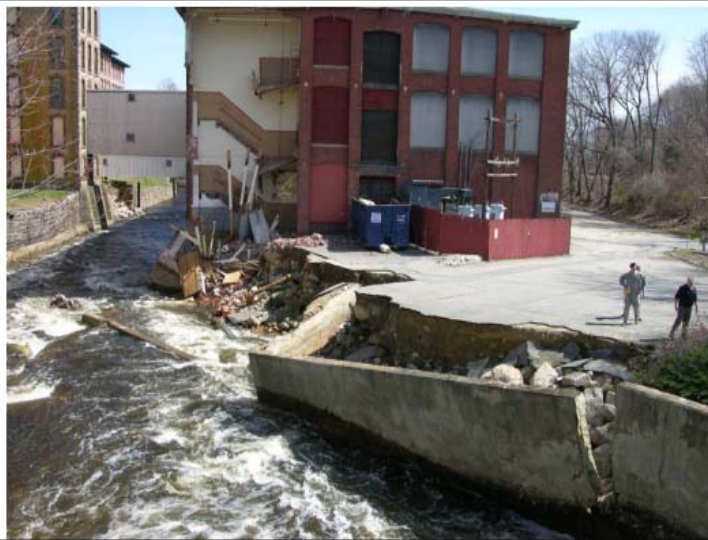
April 2010: Riverbank failure below Laurel Avenue Bridge in Coventry, RI; residents and property downstream need to be protected. The retaining wall collapses into the river.

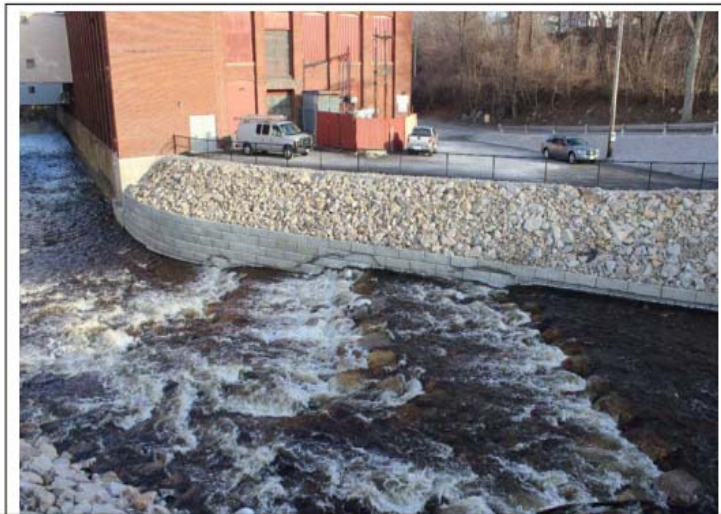
April 2010: Severe erosion has jeopardized the local businesses adjacent to the river, permanent repairs are necessary to ensure employment security and protect critical infrastructure.

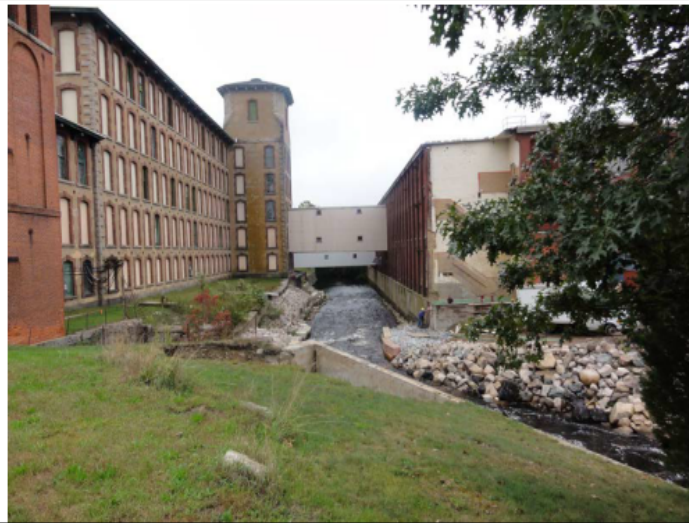
June 2010: NRCS emergency repairs included providing rock rip rap and concrete armor along the toe of the severely eroded riverbank.
