Inland Wetland Permitting and Response to Storm Damage

CT Association of Flood Managers Conference
Wednesday October 24 ,2018

Brian Carey
Conservation Director
Town of Fairfield, CT

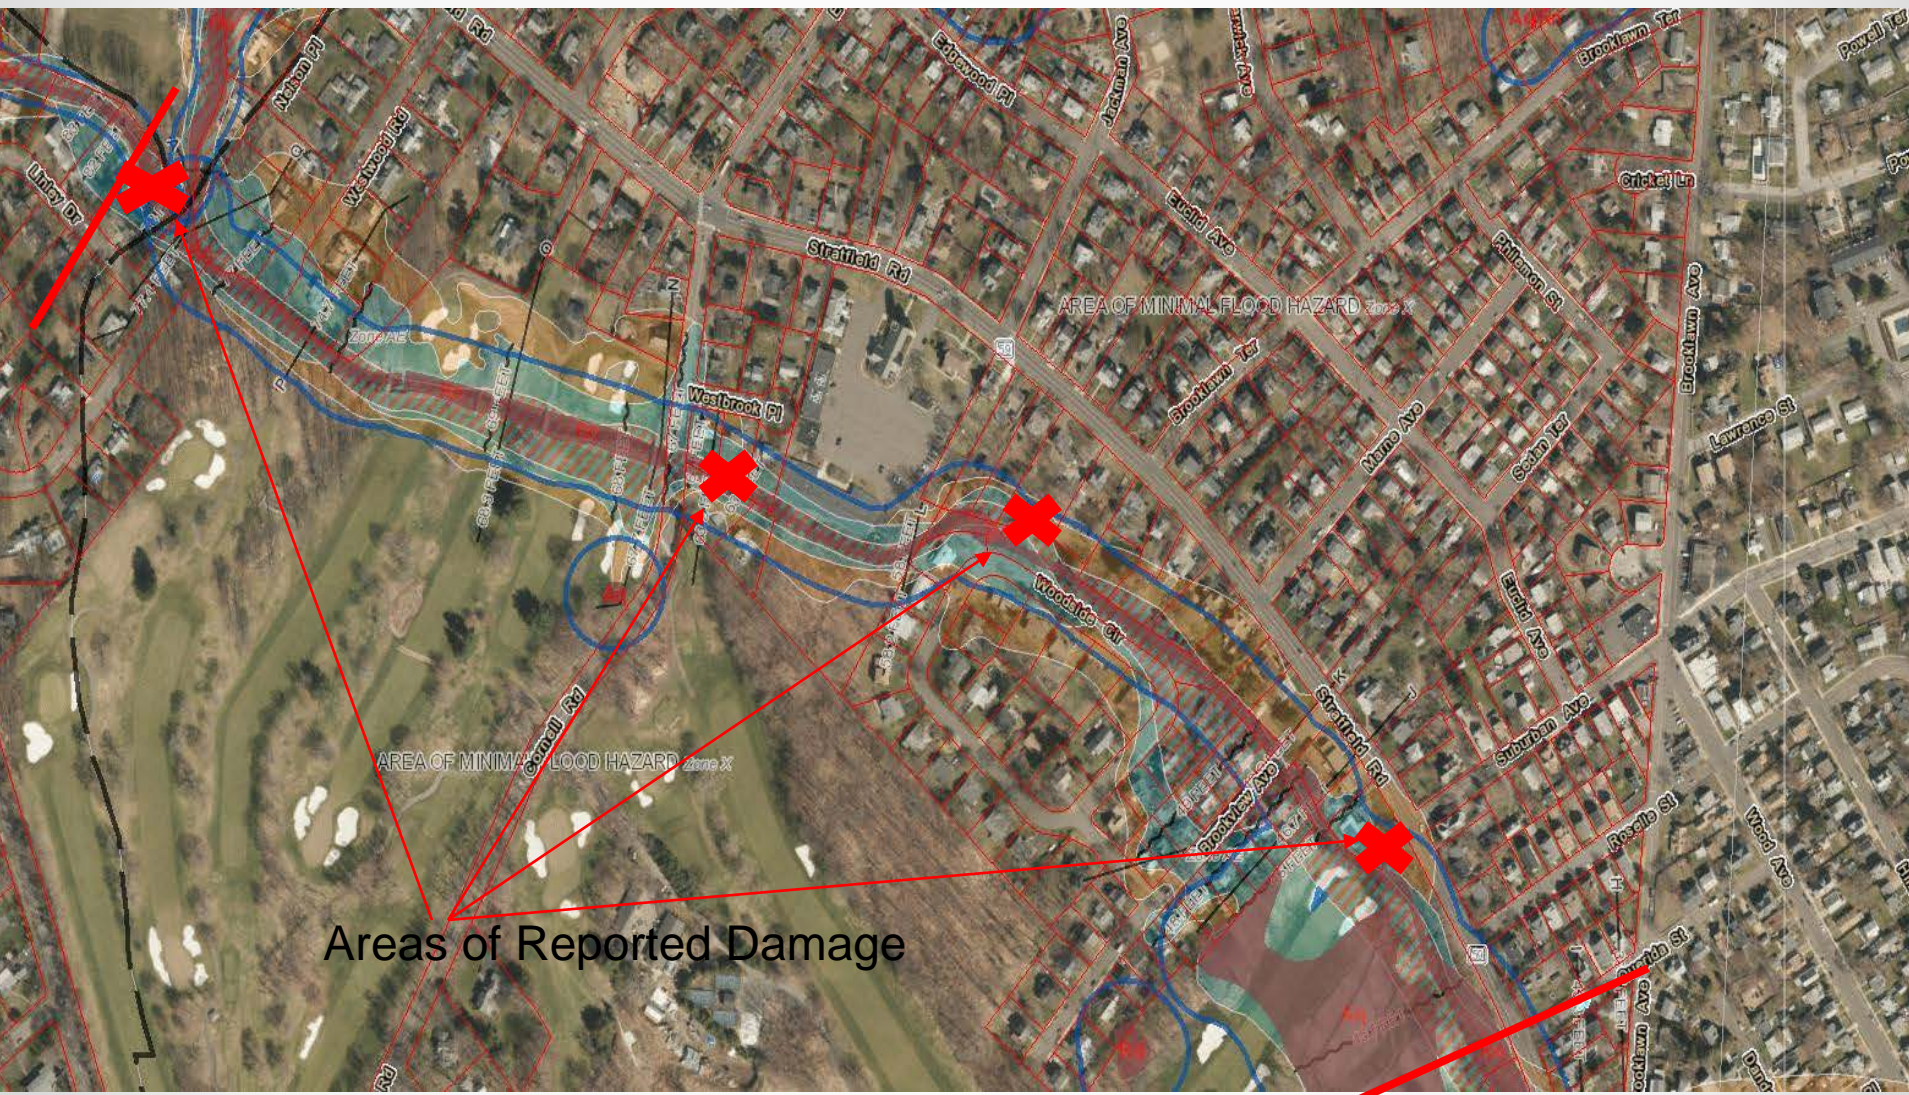
Rooster River

(Areas of Reported Damage –September 2018)

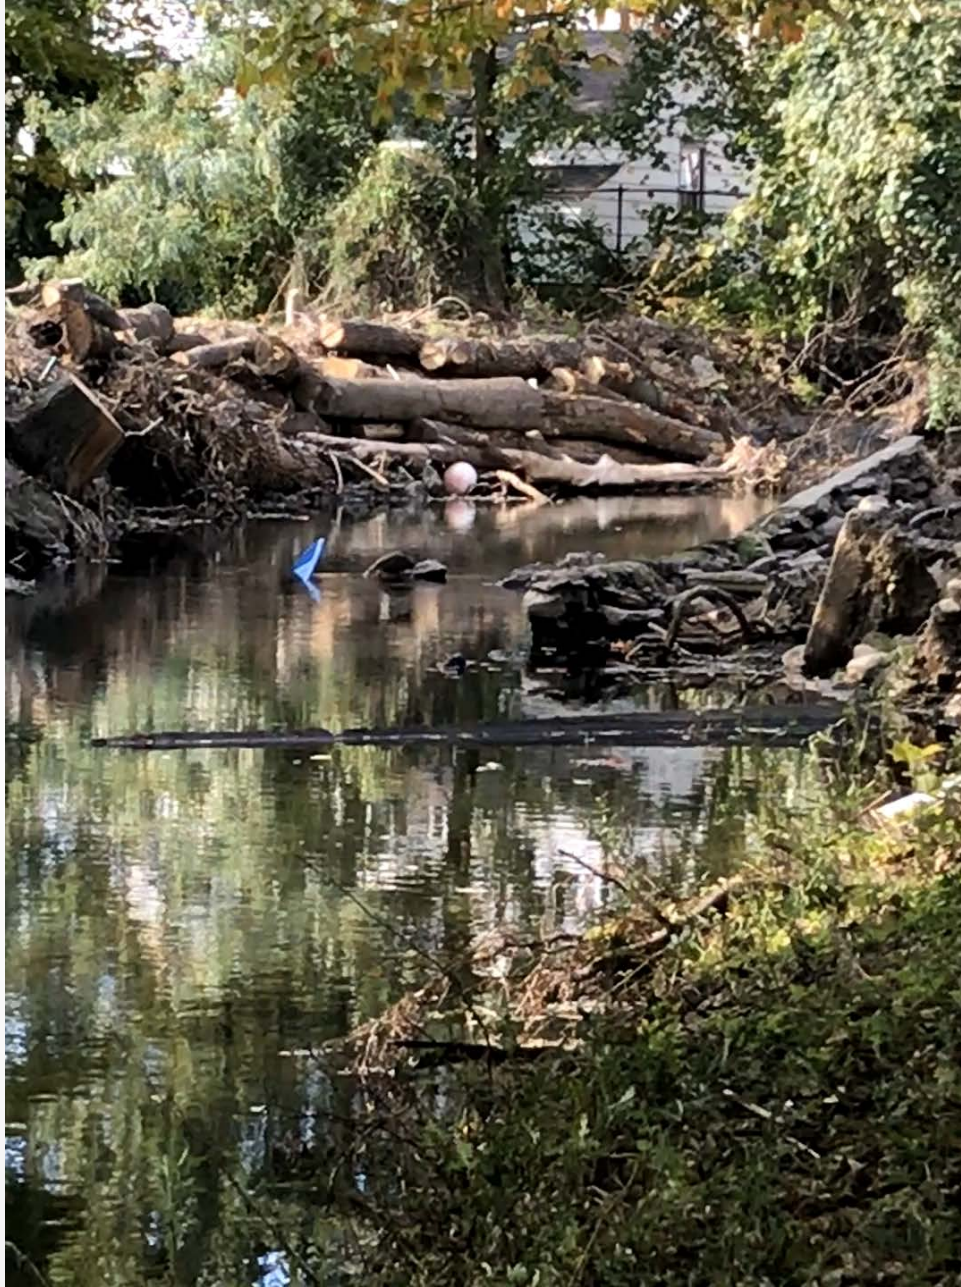
Channel Obstructions

Temporary Bank Stabilization

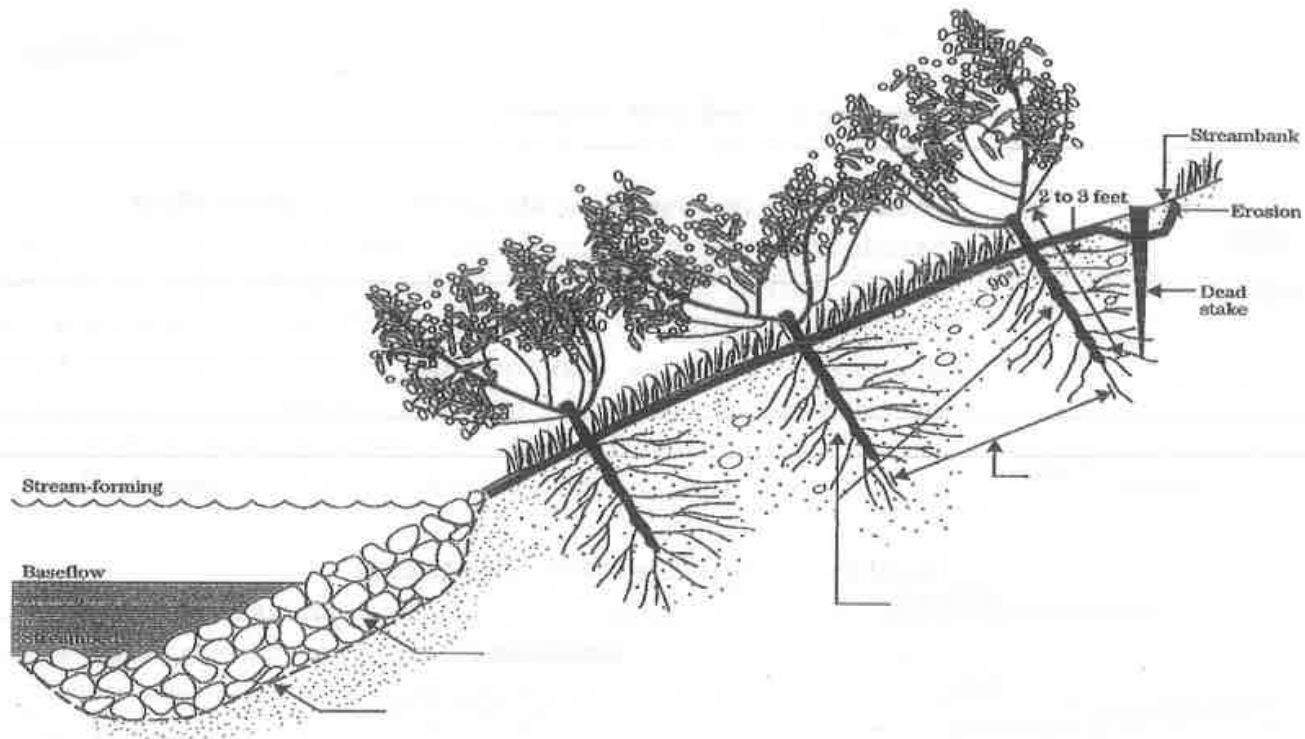
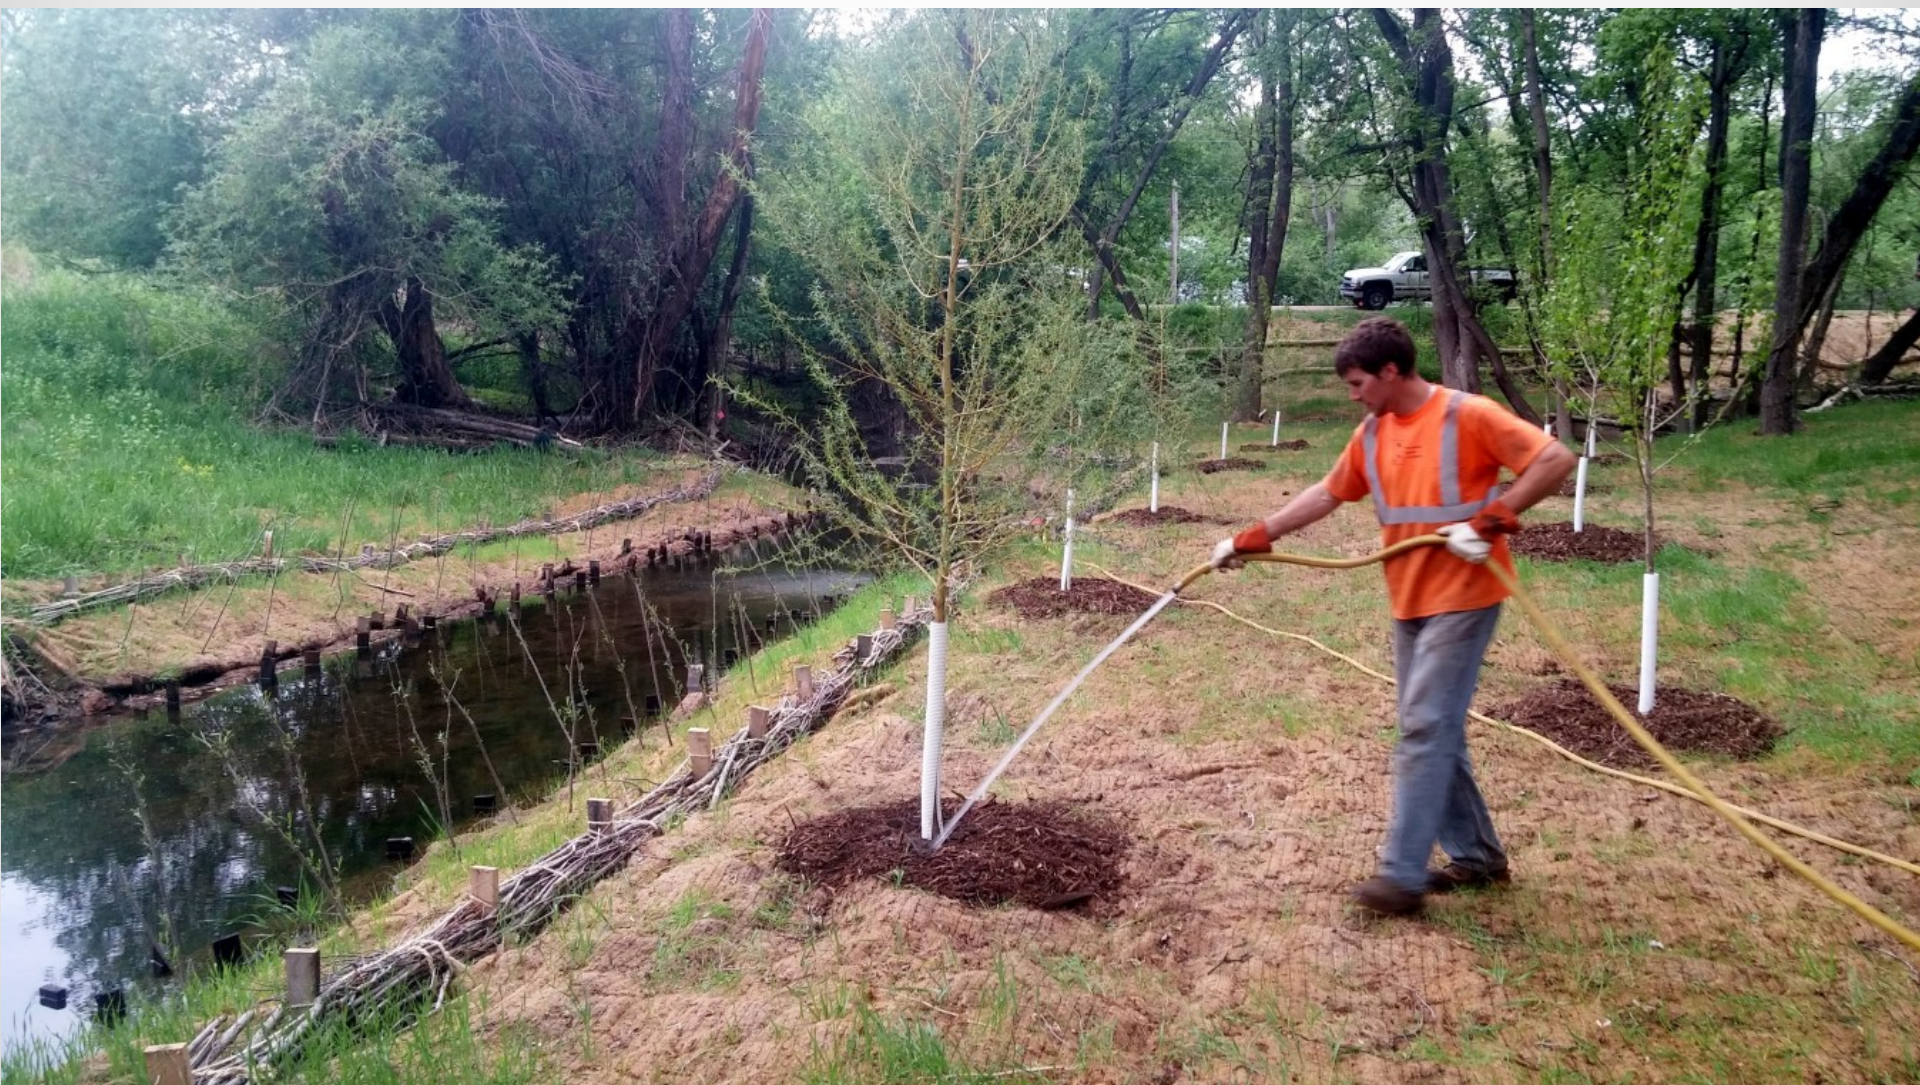
Live –Staking

Live stakes are living, woody plants cuttings capable of rooting when inserted into the banks.

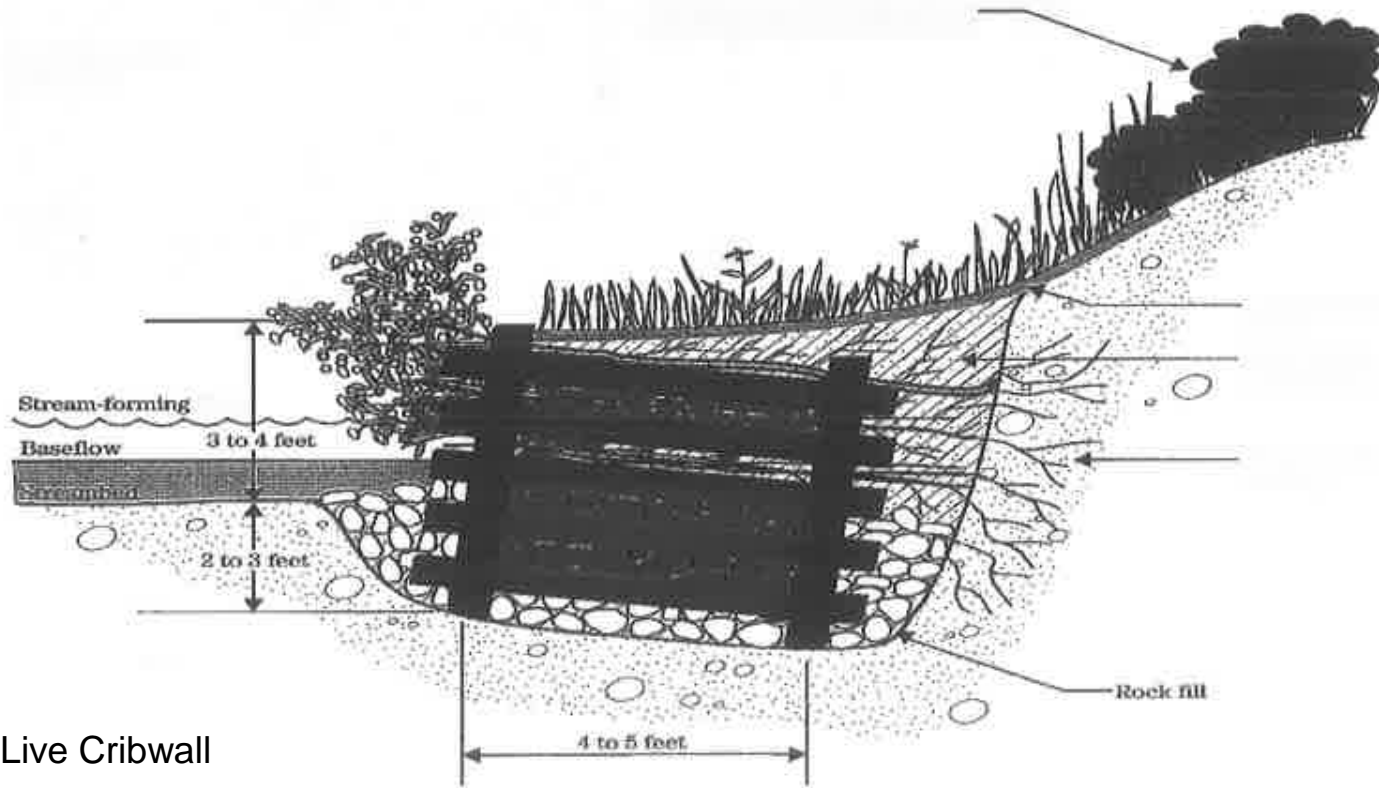
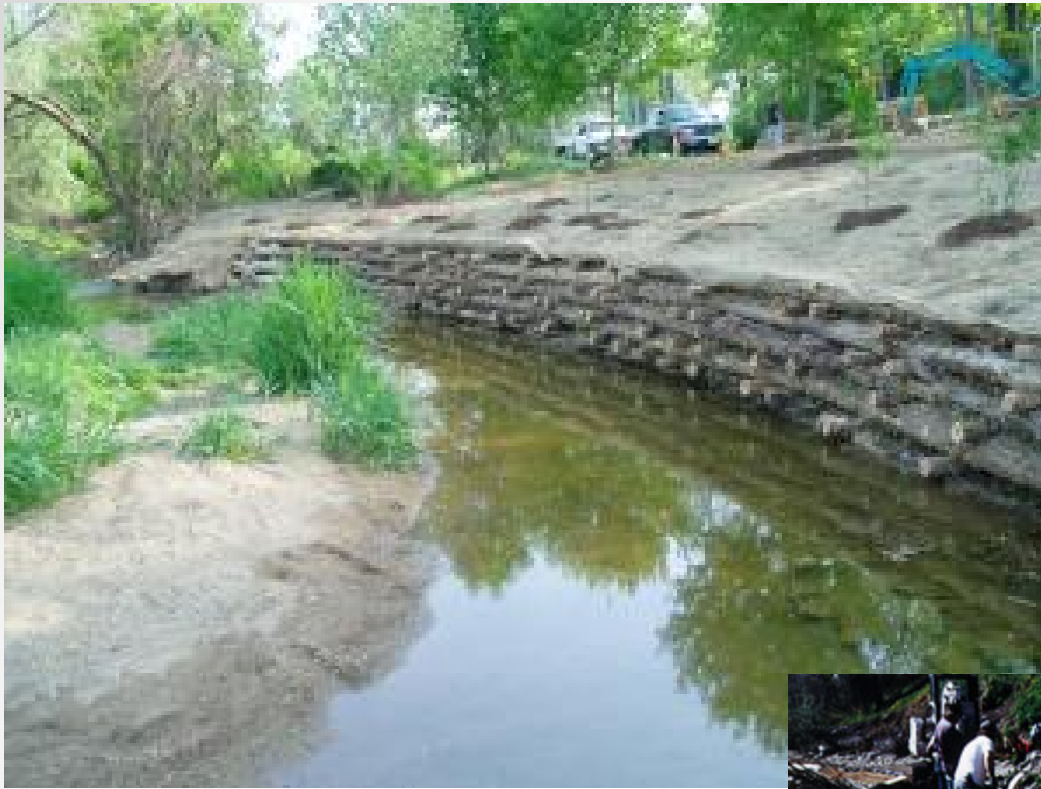
Live Cribwall

A live cribwall is a box-like structure with a framework of logs or timbers, rock and like that can protect eroding streambanks or shorelines. Once live cutting become established, mature vegetation gradually takes over the structural functions of the logs or timbers

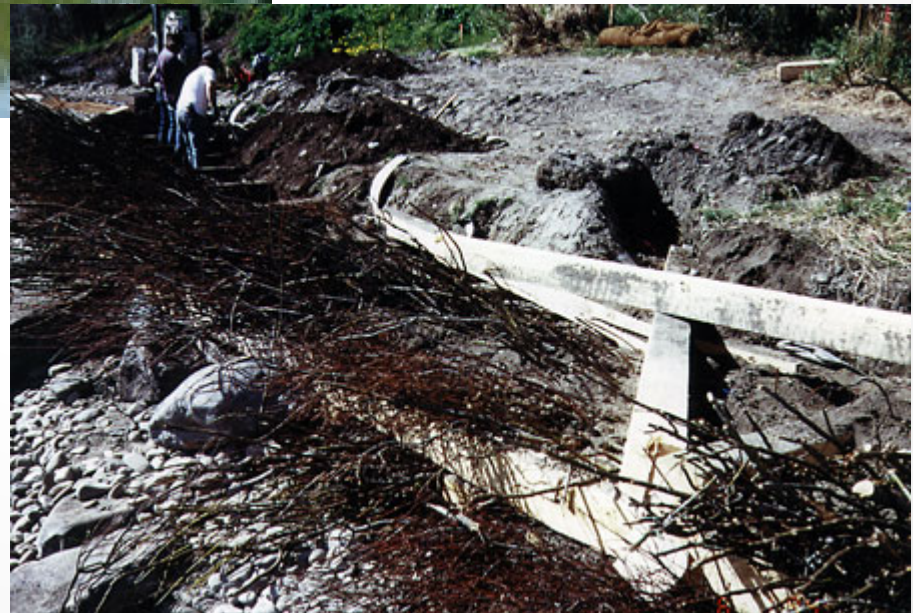
Wood cribwalls are supposed to decay over time after trees and vegetation has established and structural roots are able to maintain the grade.

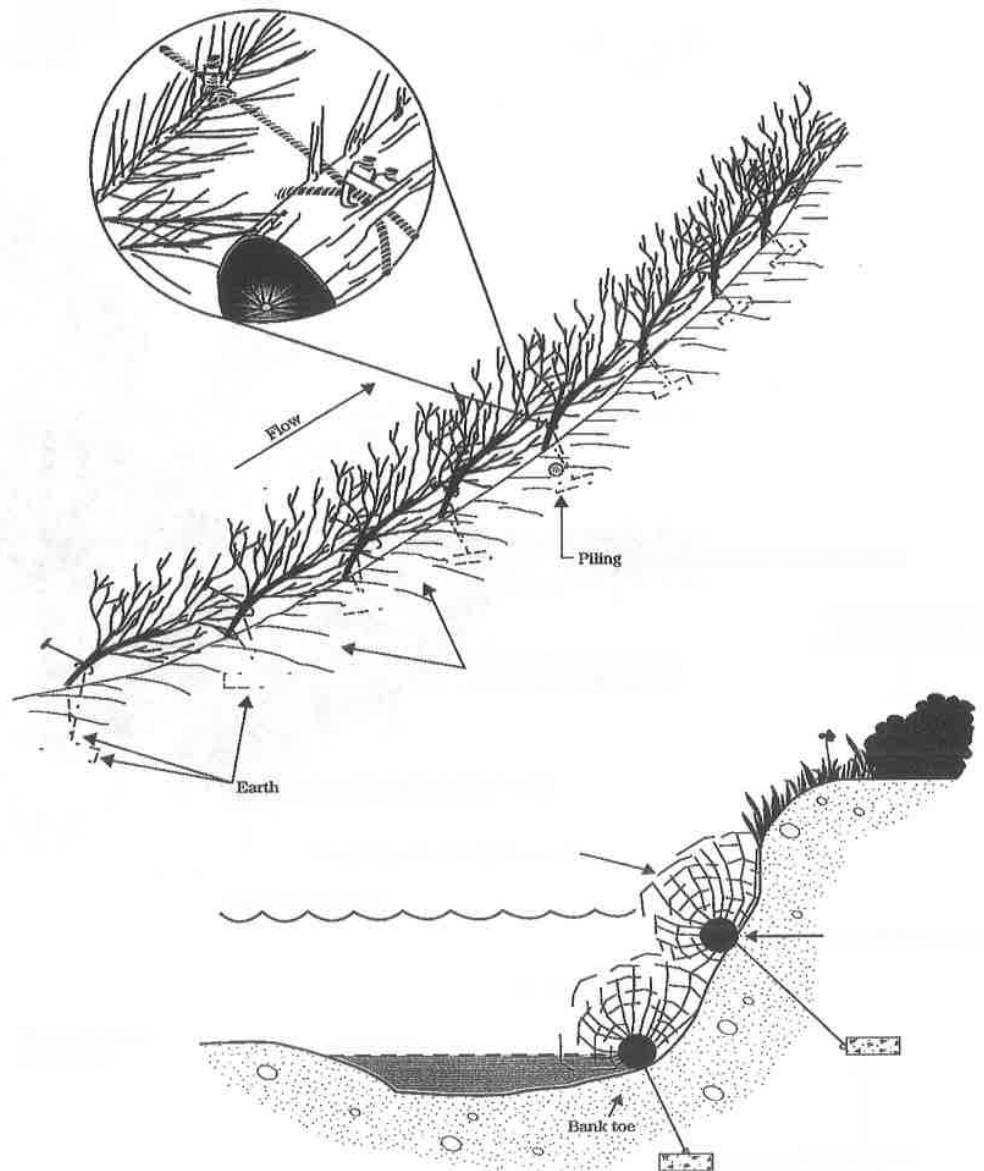
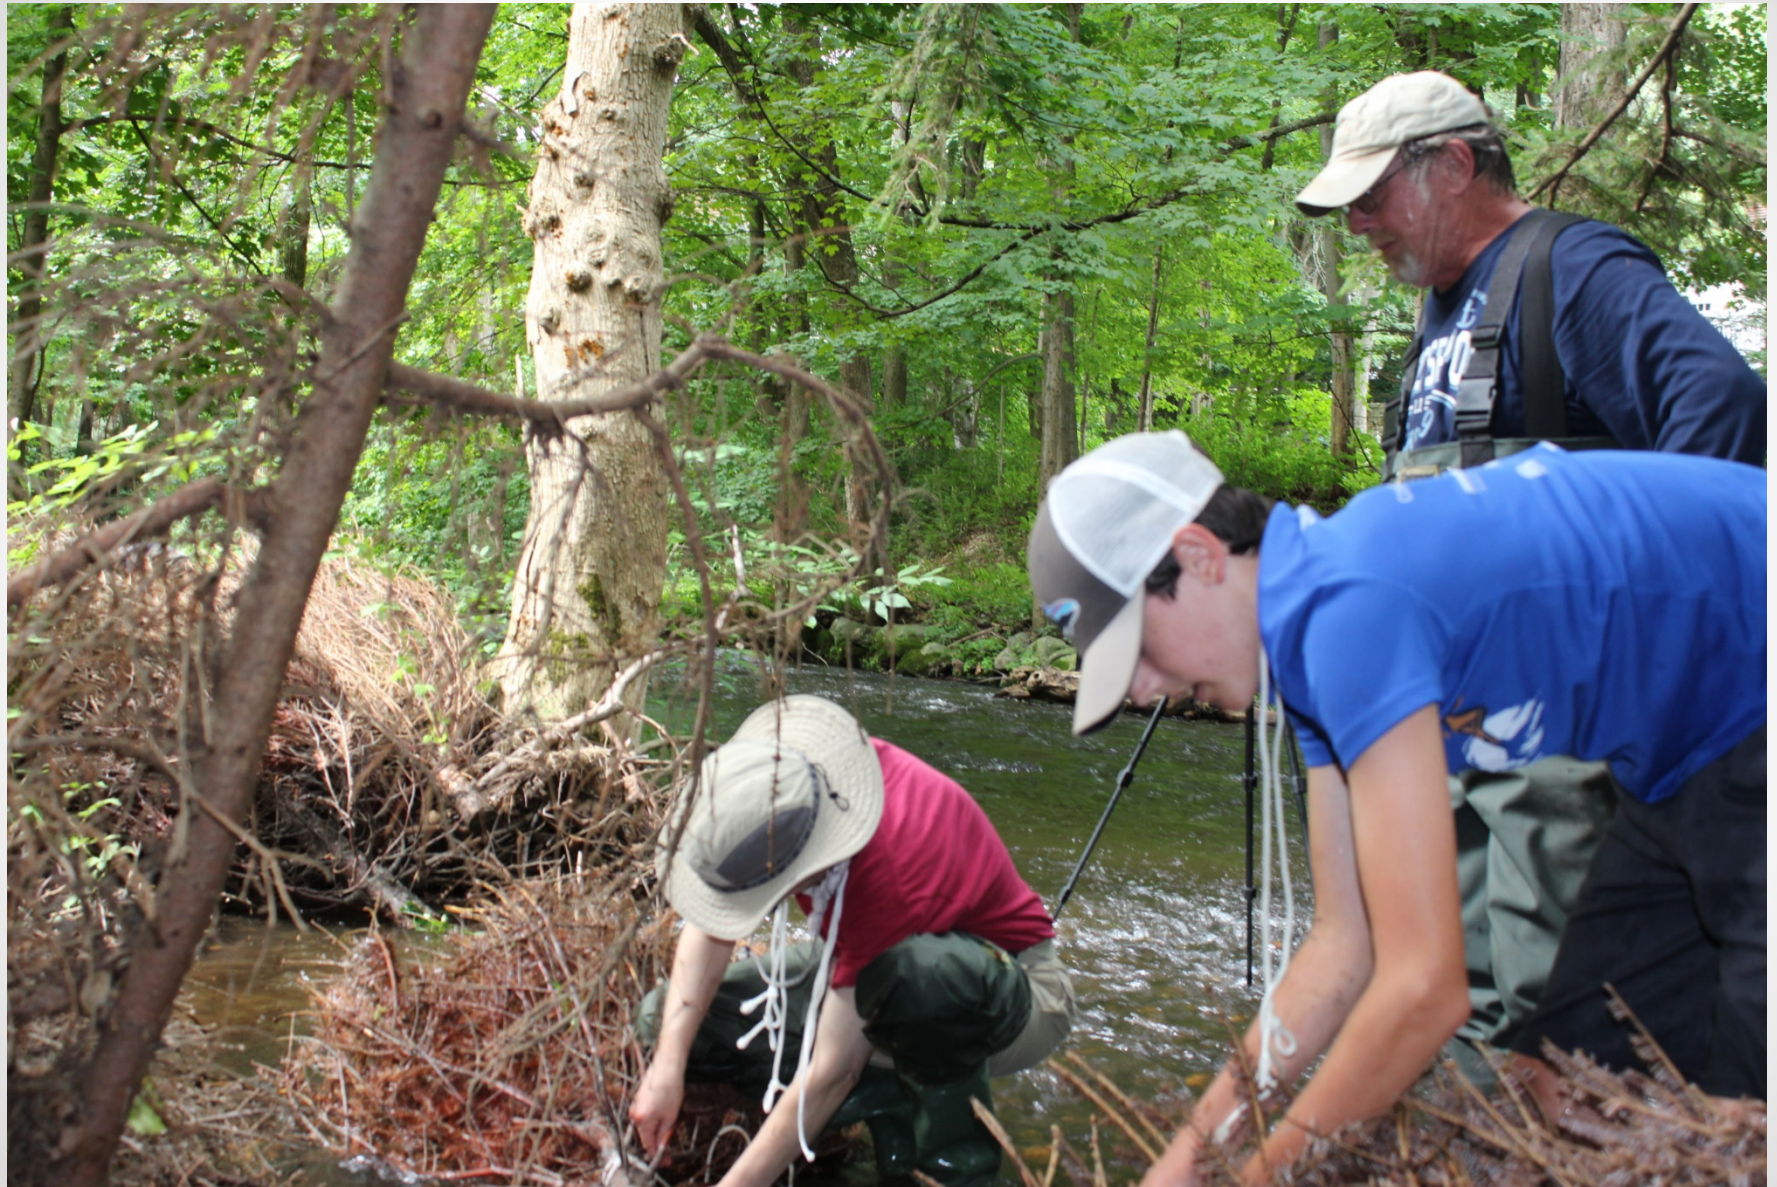
Tree Revetments

Tree revetments are rows of cut trees anchored to the toe of the bank. This a low cost method, often used for toe protection with other bioengineering techniques.

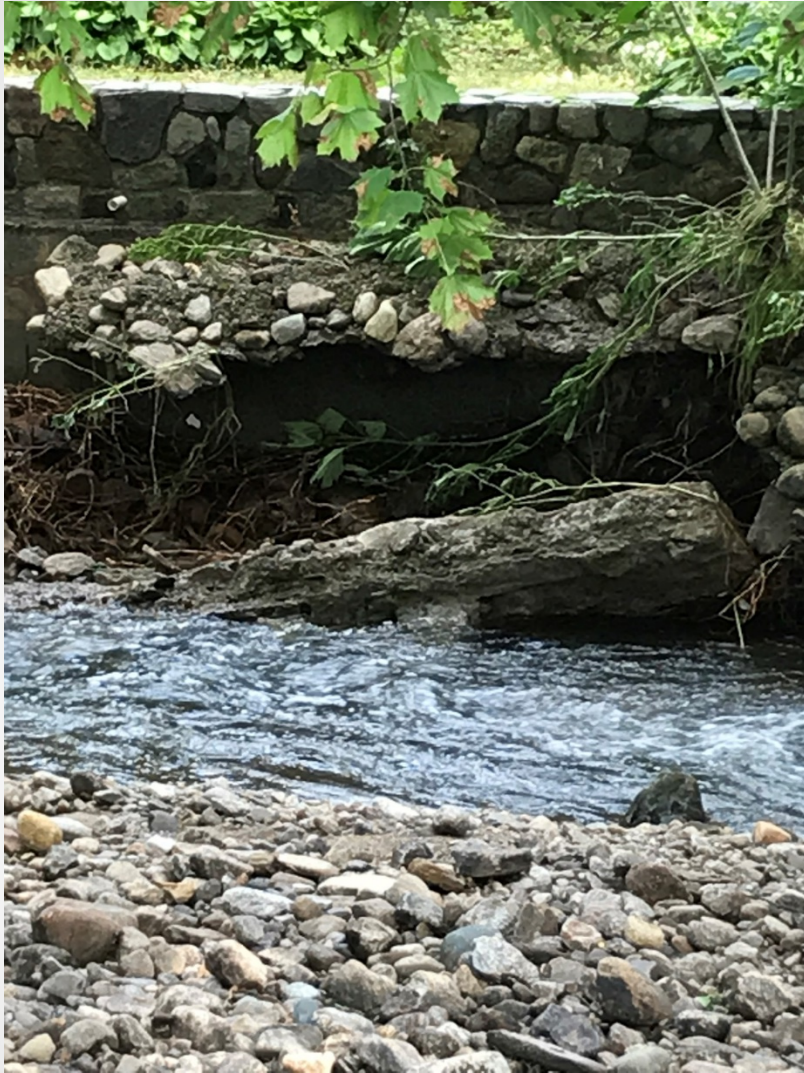
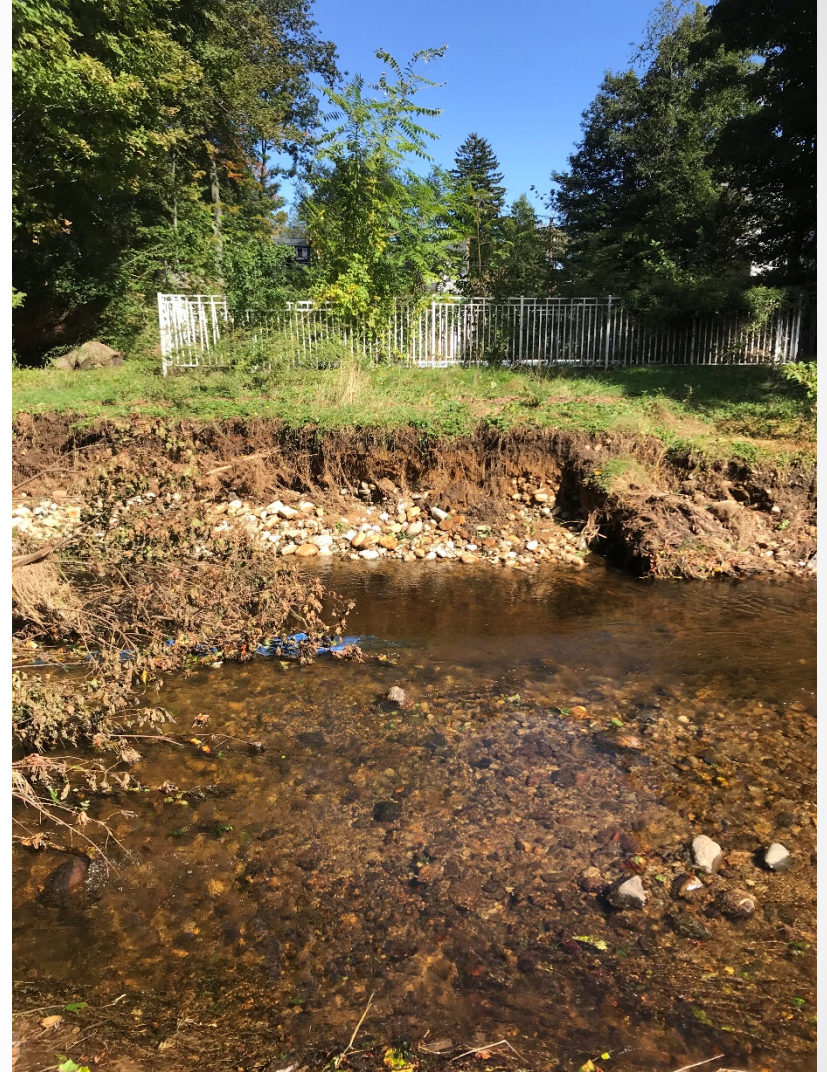
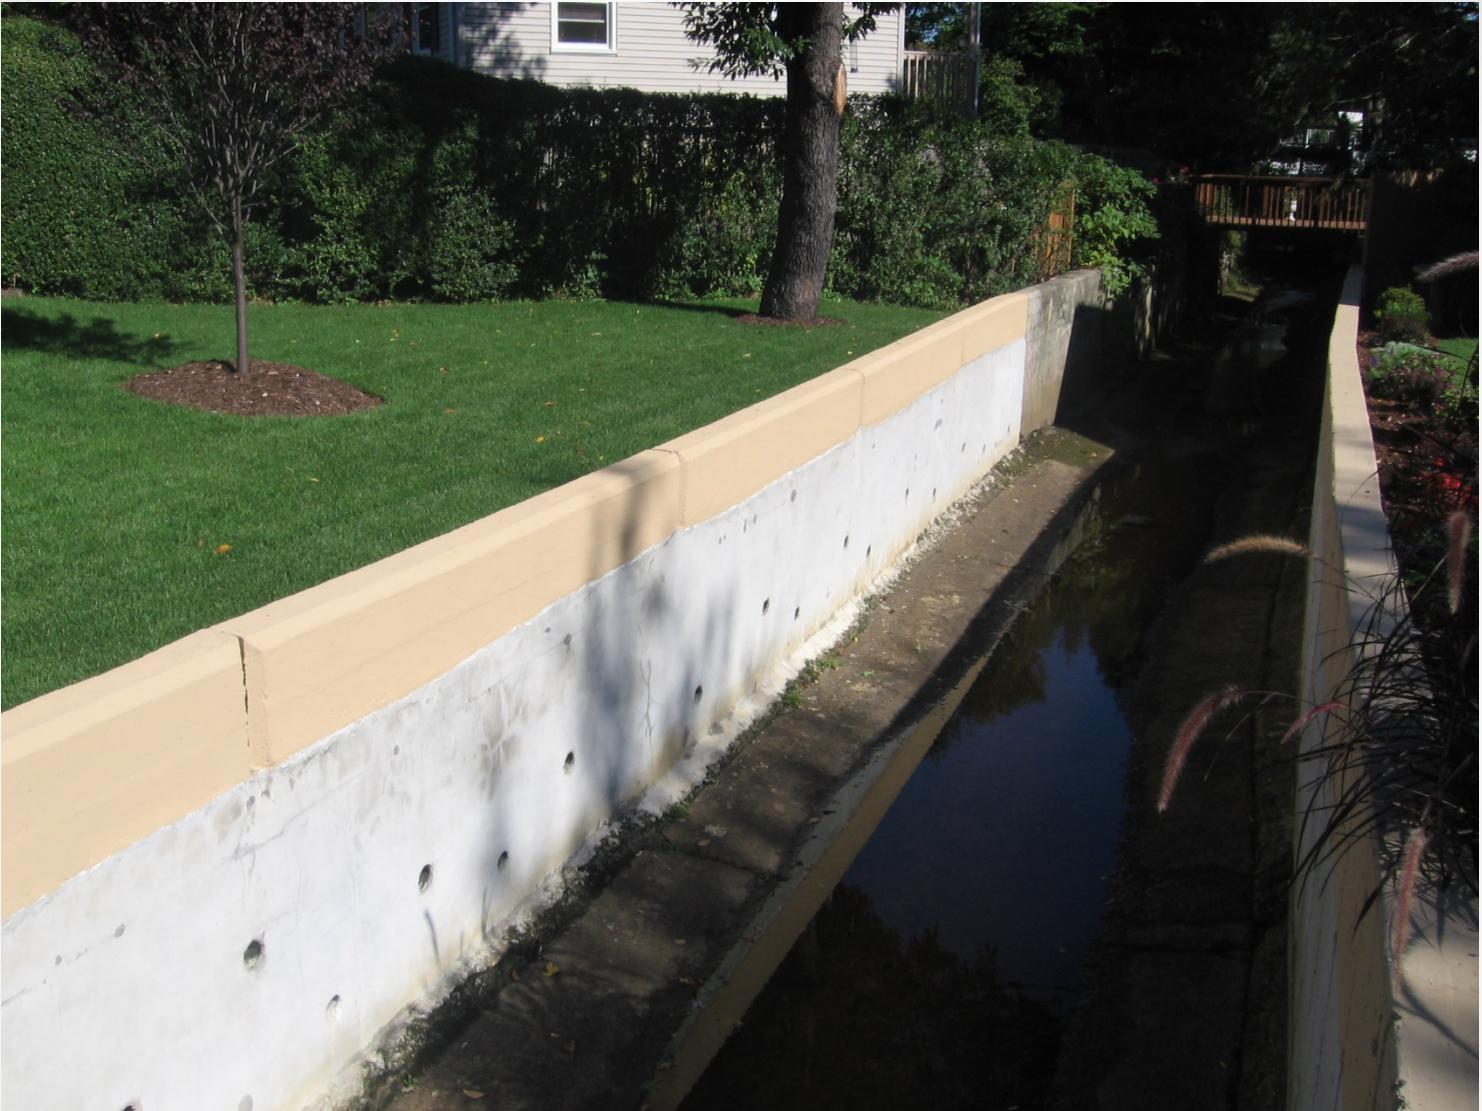
Retaining Walls and Permitting Issues

Retaining walls increase the flood height and provides little ecosystem benefits and decreased water quality.
