FARMS ROAD RECONSTRUCTION

Connecticut Association of Flood Managers Annual Conference, December 9, 2021

Daniel Lawrence, PE, Aquarion Water Company
Joseph Canas, PE, LEED AP, CFM, Tighe & Bond

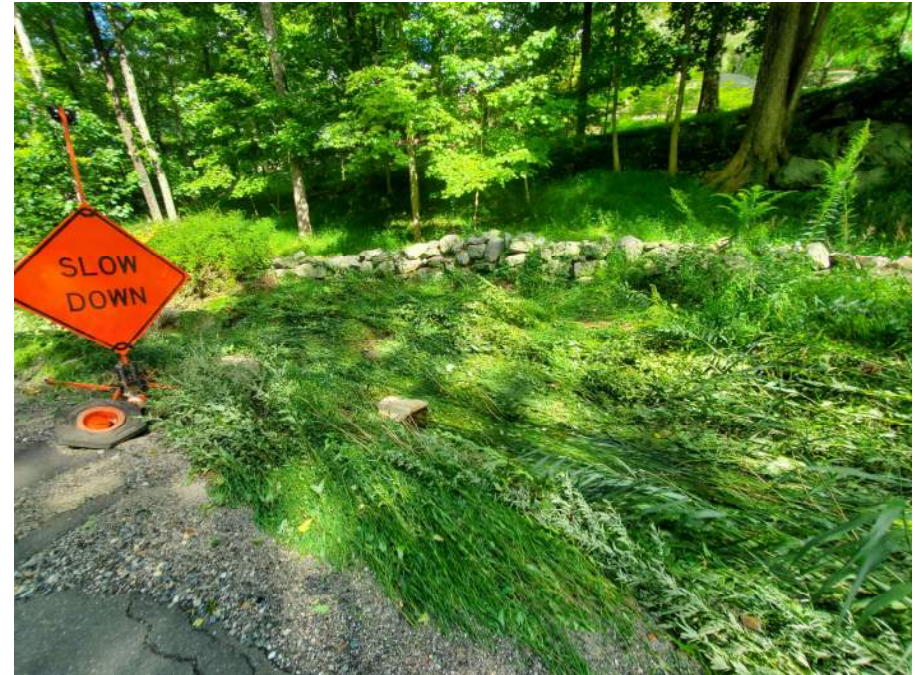
- About 1,000 feet of roadway was washed out
- Floodwaters churned and tore up the temporary pavement
- “Cut through route” between North Stamford and Greenwich / Merritt Parkway closed to traffic
- Detour route ~ 4.5 to 5 miles

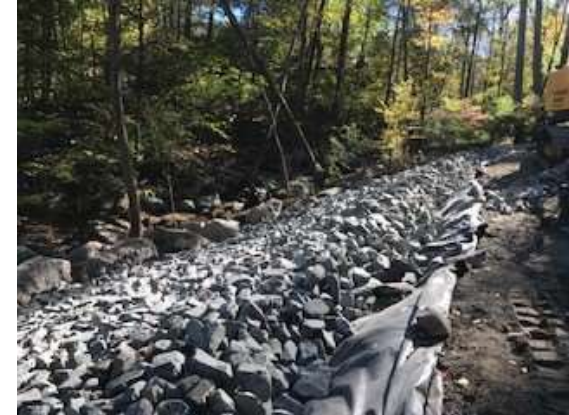
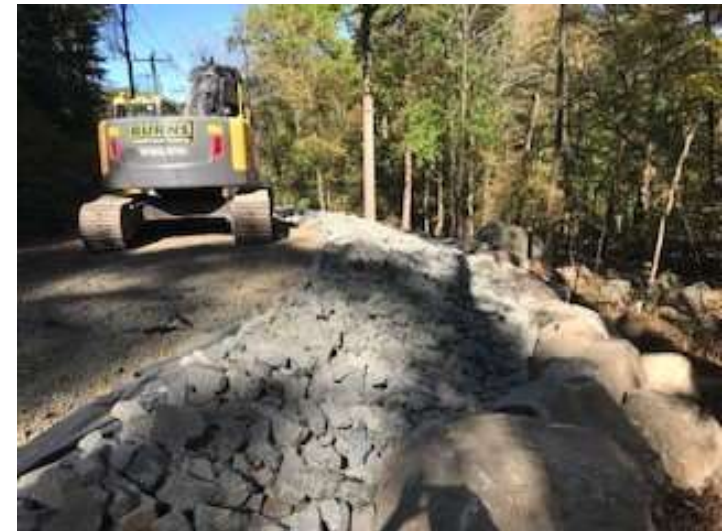
- Documenting what was there before:
 - LiDAR, Aerial Photos, Google Street View, Pre-Project Photographs
- Detailed culvert inspection revealed serious condition with roof slab
- Unforeseen conditions
- The weather

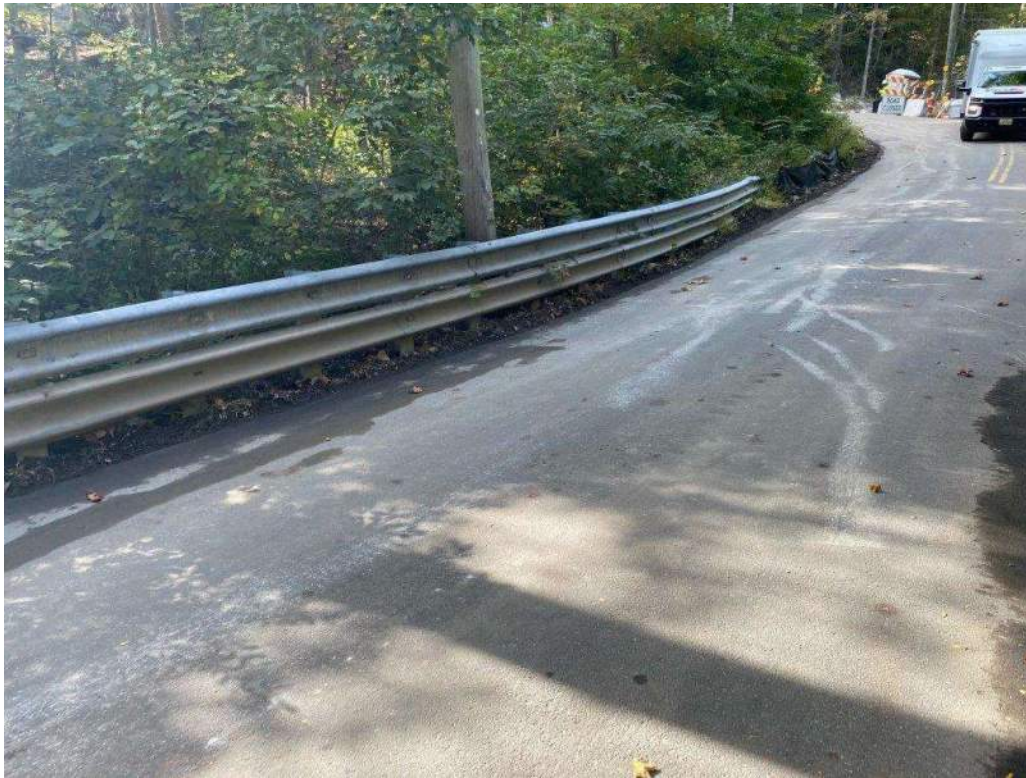
Removal of loose debris and stones east of hairpin turn, at bottom of hill

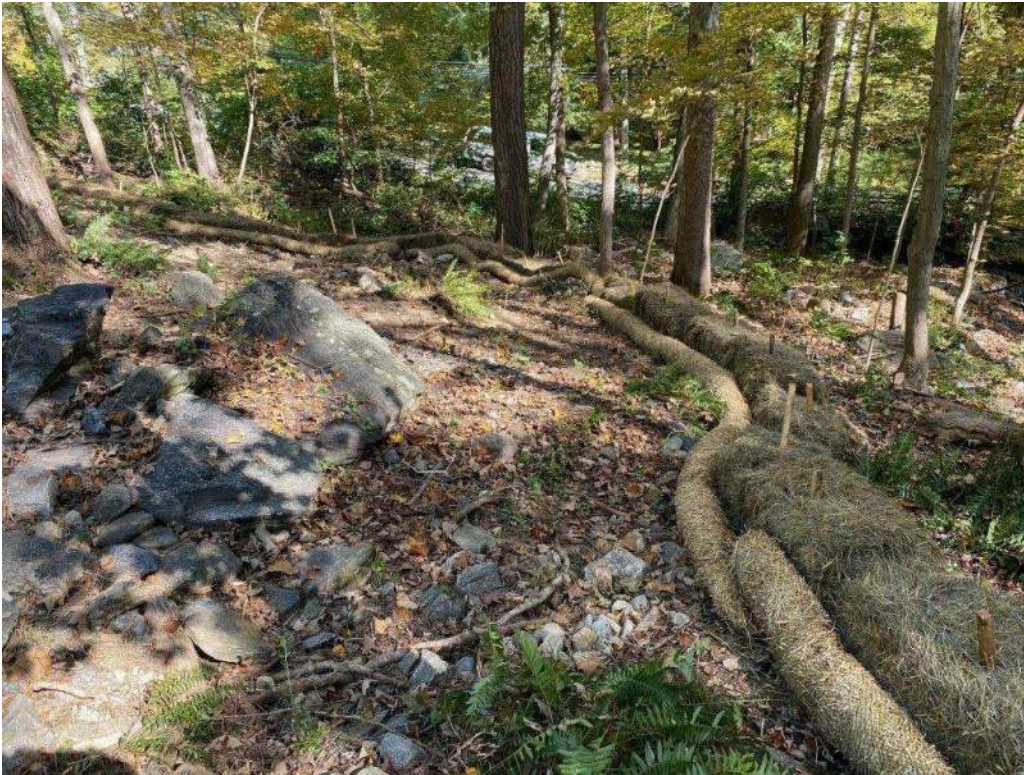
Sediment and erosion controls at toe of slope

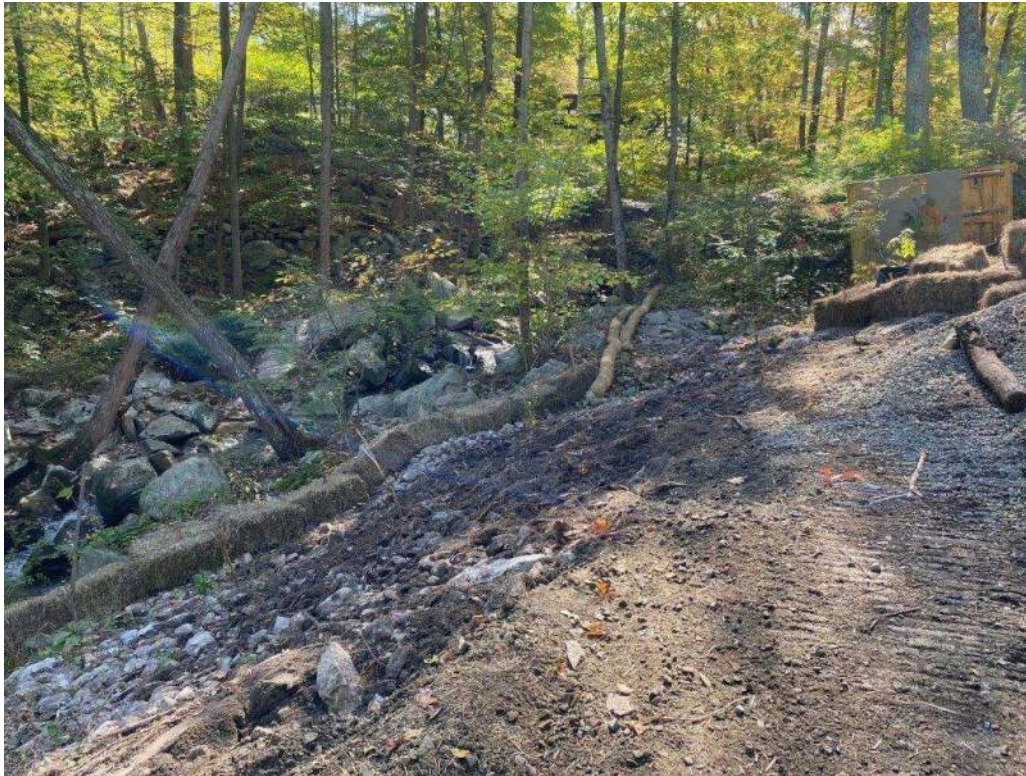
Sediment and erosion controls at toe of slope

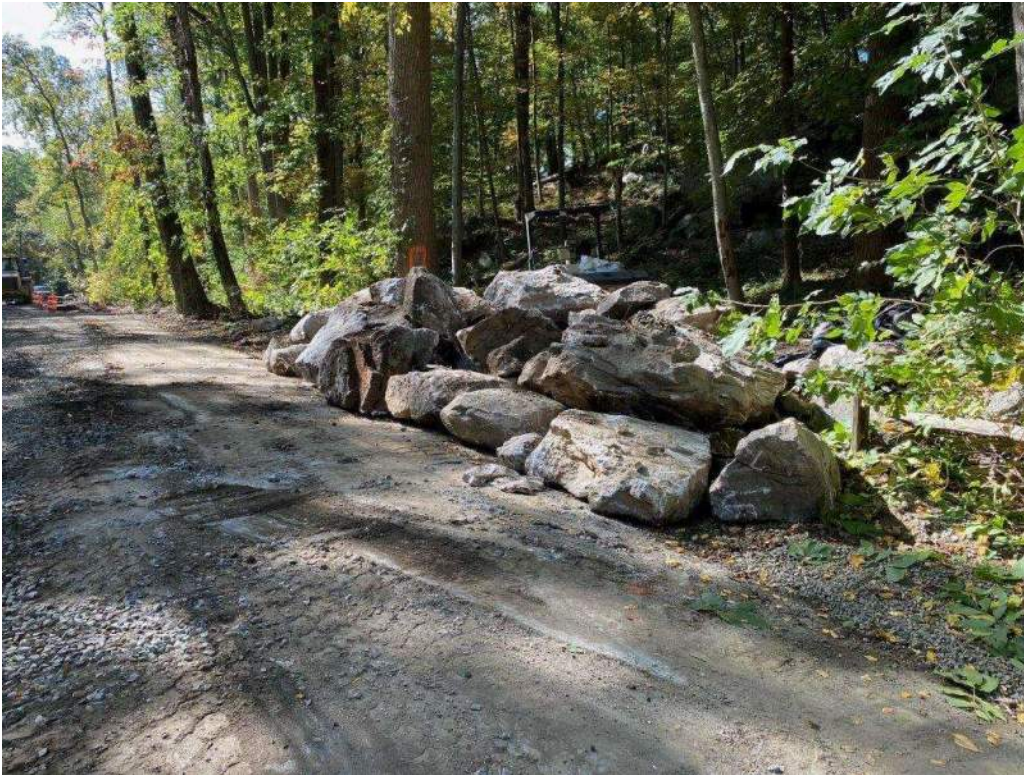
**Stockpiled Boulders
removed from failed slope to
create new toe**

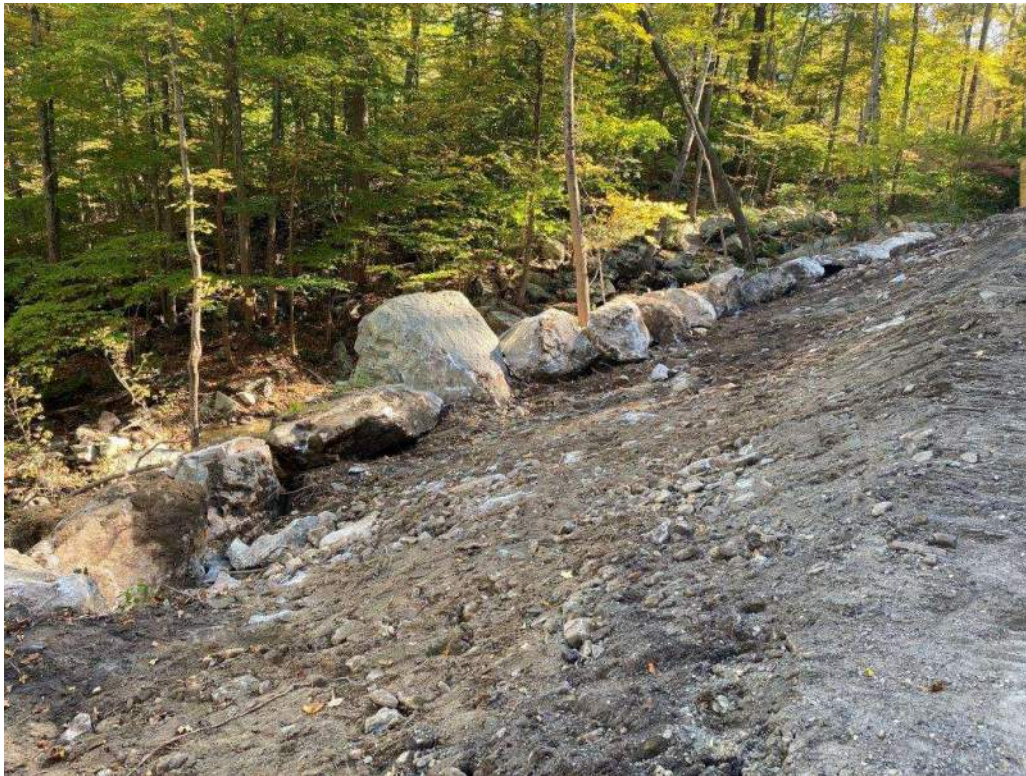
**Boulders placed to create toe
for riprap armored slope**

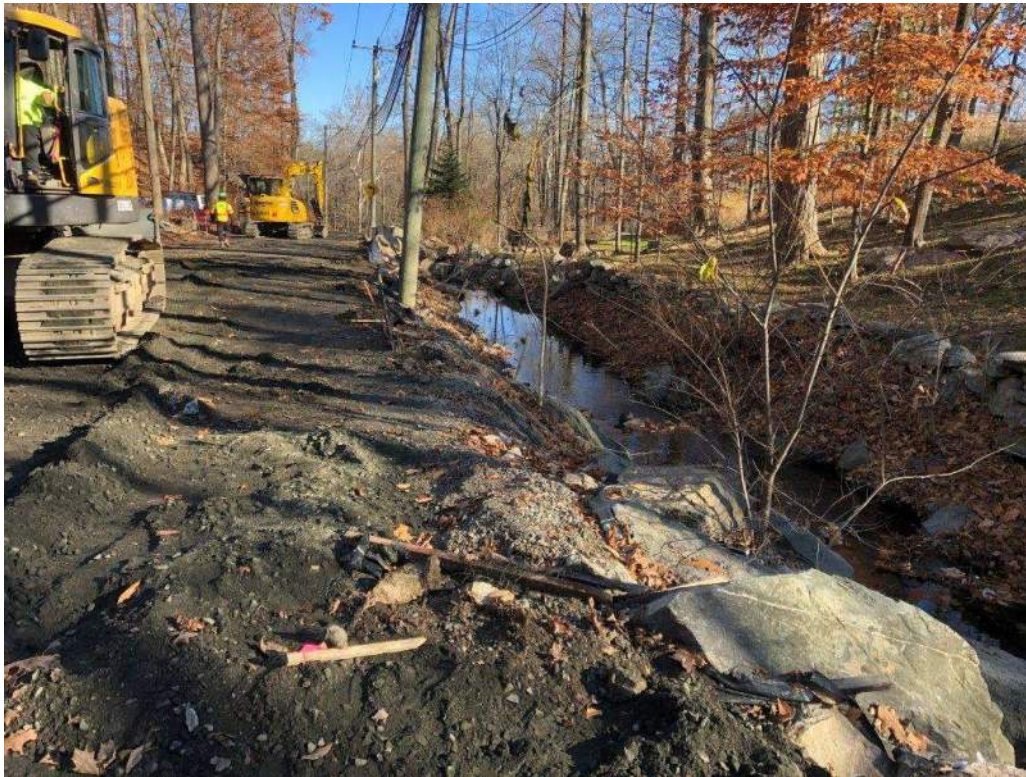
**Removal of existing guiderail
to facilitate construction**

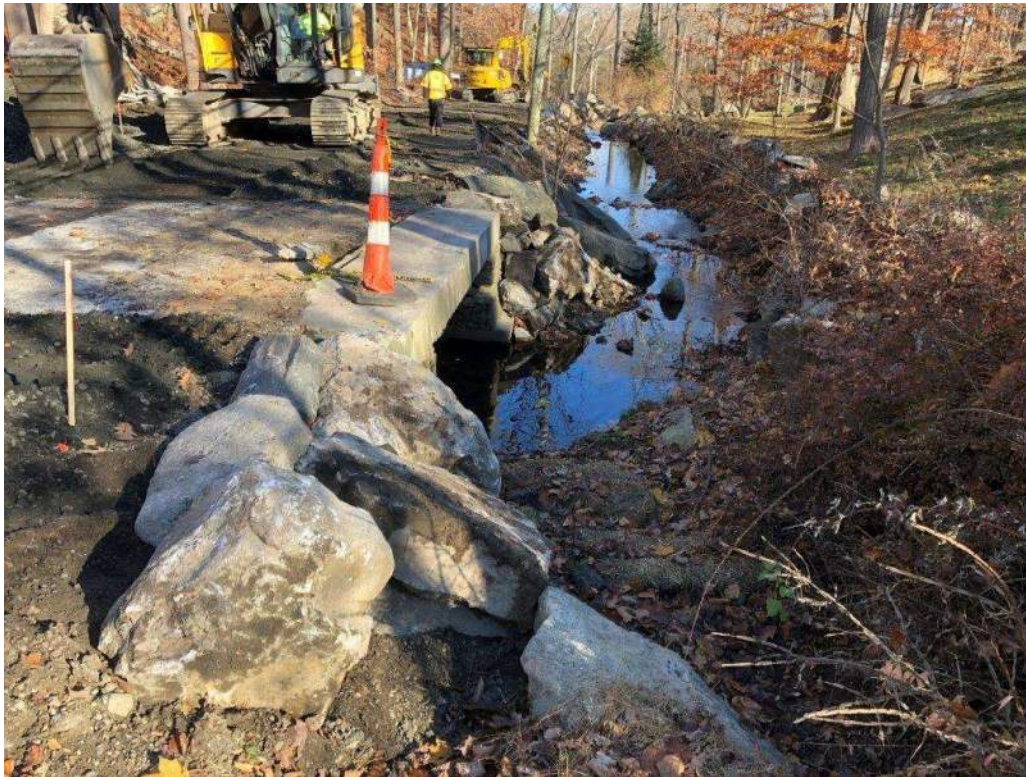
Boulder placement to protect
1930s era culvert
