# **Connecticut Department of Transportation - Bridge Scour**

Hydraulics & Drainage Unit

November 13, 2024

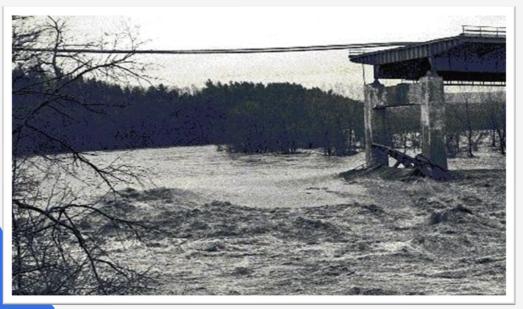
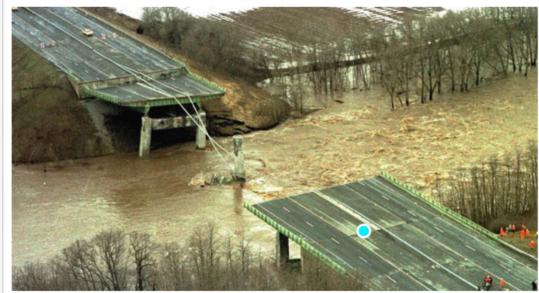
- Push from FHWA for States to evaluate all bridge structures for scour
  - Technical Advisory Evaluating Scour at Bridges (Oct. 28, 1991)
  - Federal Regulations 23CFR 650 Subpart C National Bridge Inspection Standards.
  - Connecticut initiated evaluation of all bridge structures.
- This was largely a result of the Schoharie Creek Bridge Collapse in Fort Hunter, New York.
  - Failed due to scour of weak rock under the spread footings.

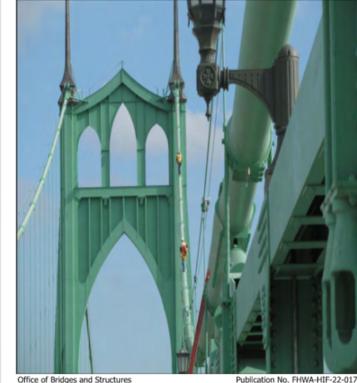
*Specifications for the National Bridge Inventory*

No. FHWA-HIF-22-017 March 202

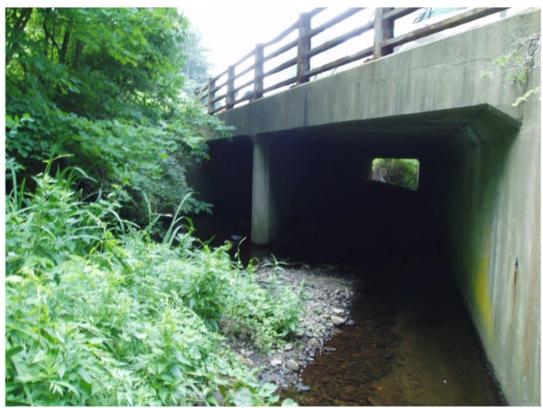
- Sediment Deposition is common at multi-box culvert crossings.
- Can be due to poor alignment.

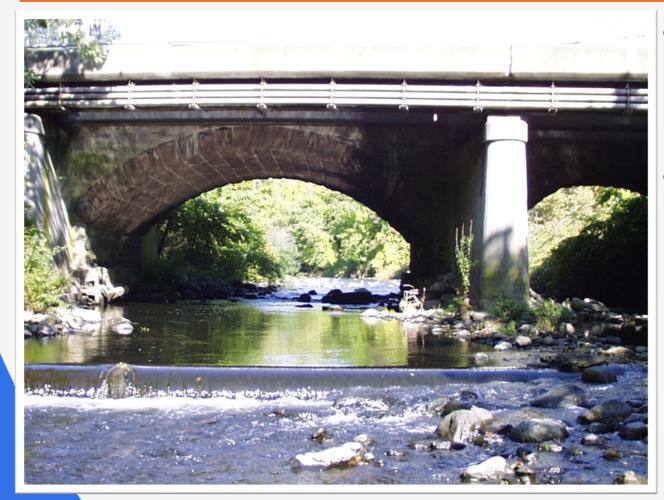
- The lowering or scouring of the streambed over relatively long reaches due to deficit in sediment supply from upstream.
- Downstream exposed utility pipe indicates possible degradation problem.

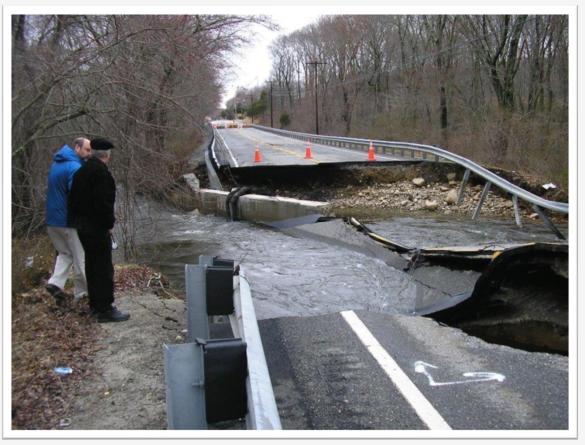
- Proj No. 137-153, Bridge No. 02779 Failure: Rt. 184 in Stonington, March 2010 Tropical Storm Irene
- Contraction at Inlet Generates High Velocity, Pressure Flow Condition Exacerbating Local Scour, Undermining Outlet Wingwall.
- Proposed: Larger Span Structure with Riprap Spill-Through Abutments on Piles.

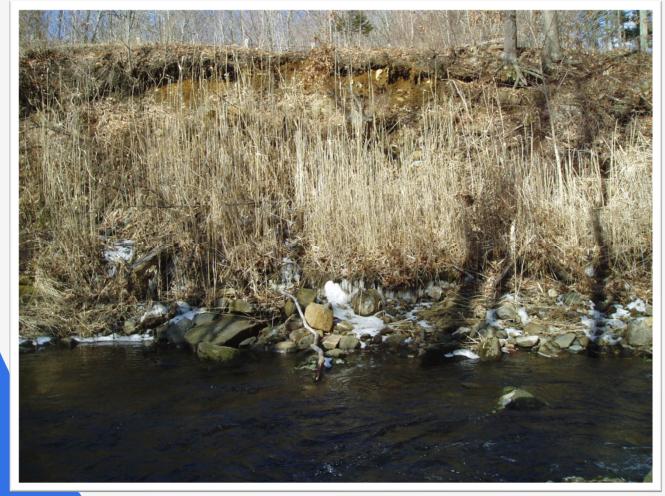
Lateral Stream Migration Case: Bank Erosion on Outside of River Bend.

Project No. 0149-0088: Route 45 in Warren on March 2020 Embankment Failure due to Stream Meandering.

Proposed: Riprap Revetment

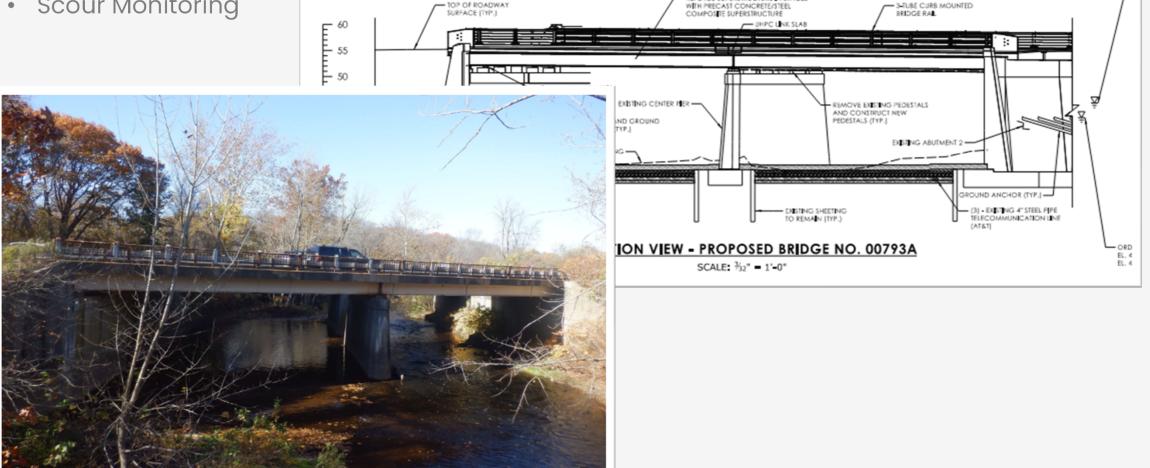
# Scour Mitigation/Prevention/Monitoring

- Bridge Foundation Types and Depths
- Bridge Scour Countermeasures
- Scour Monitoring •

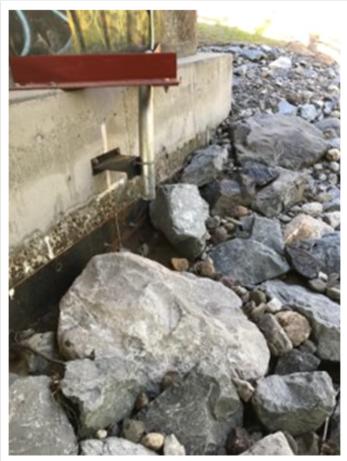
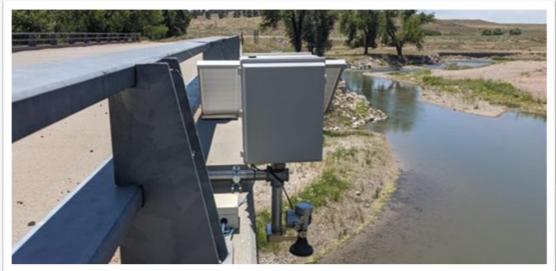
### **Scour Monitoring**

- Scour Critical Structures NBIS Item 113 Rating of 3.
- Scour Monitoring Systems
- Bridge Watch

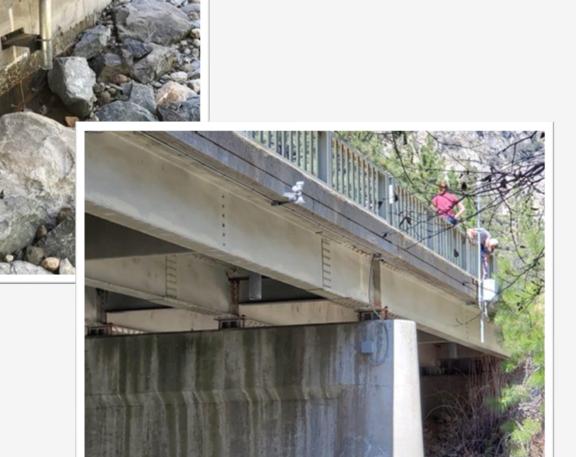
Active Sonar Monitoring Station

Pros •Continuous Real Time Monitoring •Records erosion and deposition	Cons •Interference caused by biological material (plants/fish) •Requires intensive installation process
---	---

• Tilt Monitor

Continuous real time monitoring
.1 degree resolution Easy installation

#### Cons •Provides only limited information about the scour occurring, only the health of the bridge
